CITY OF MINERAL POINT, WISCONSIN

400,000 Gallon Capacity
Tower Number One - Hydropillar

Elevated Water Tank Inspection Report

KLM Project
MN3961

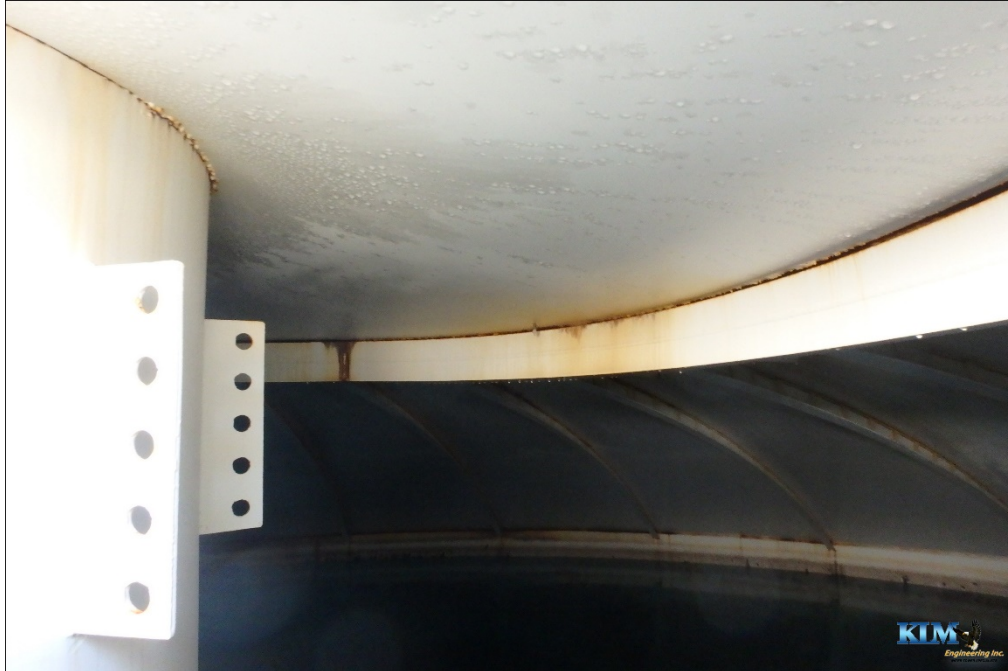
Photo No. 2
Overall condition of interior wet coating above HWL

- 3.2.3** Overall, the interior wet coating is in fair condition. Due to the age of the coating, it is not considered repairable and has far outlived a typical coating service life. Typical service life of a properly maintained coating is generally 20 to 25 years. The coating should be replaced within the next year. See photos 2 through 13, 15, 16, and 18 through 20.

- 3.2.4** After structural repairs are completed, all the reservoir surfaces should be abrasive blasted to an SSPC-SP-10 Near White Metal Blast and coated with a zinc/epoxy system (similar to the Tnemec Series 91-H20 Hydro-Zinc/Series N140 Pota-Pox Plus Epoxy coatings or Sherwin Williams epoxy equivalent).

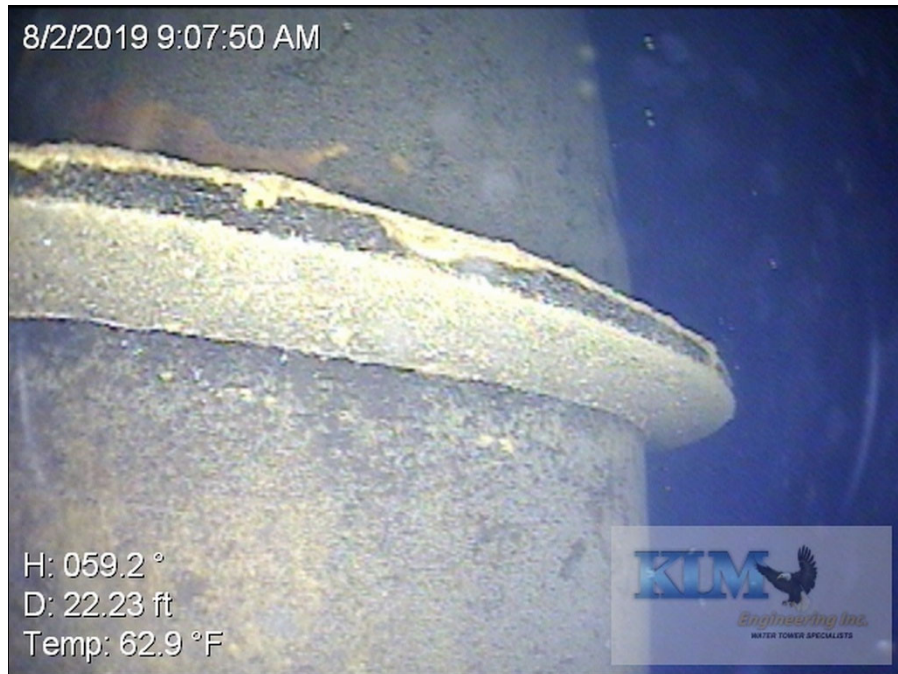
Photo No. 8
Condition of interior wet coating on drywell tube at stiffener ring
Rust coloration due to corrosion

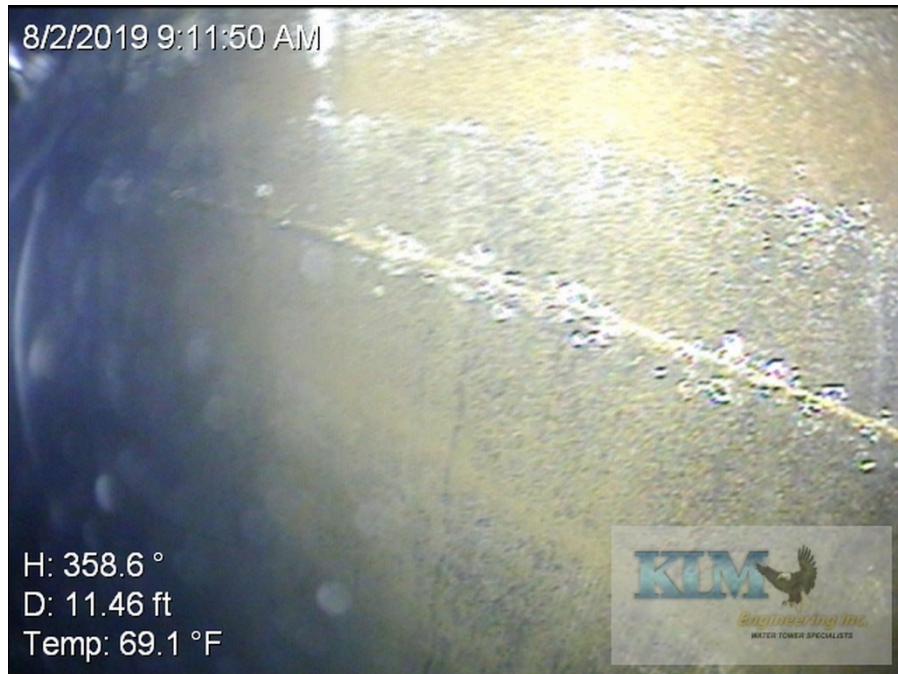
Photo No. 10
Condition of interior wet coating just below HWL
Dark scale formation on shell

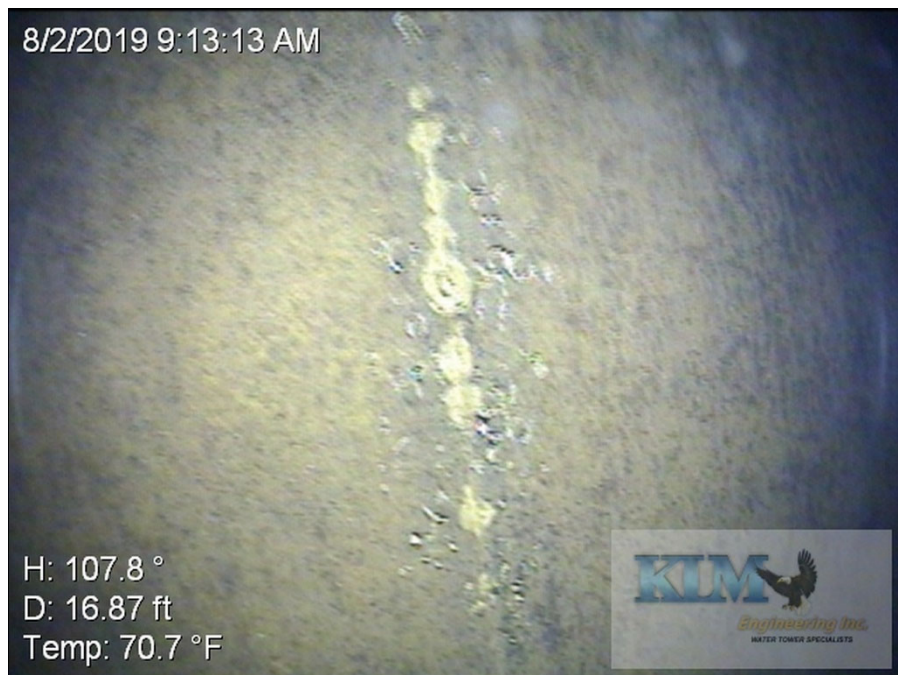
Photo No. 11
Condition of interior wet coating on shell wall
Heavy scale and staining visible; coating blistering and pinhole corrosion along welds

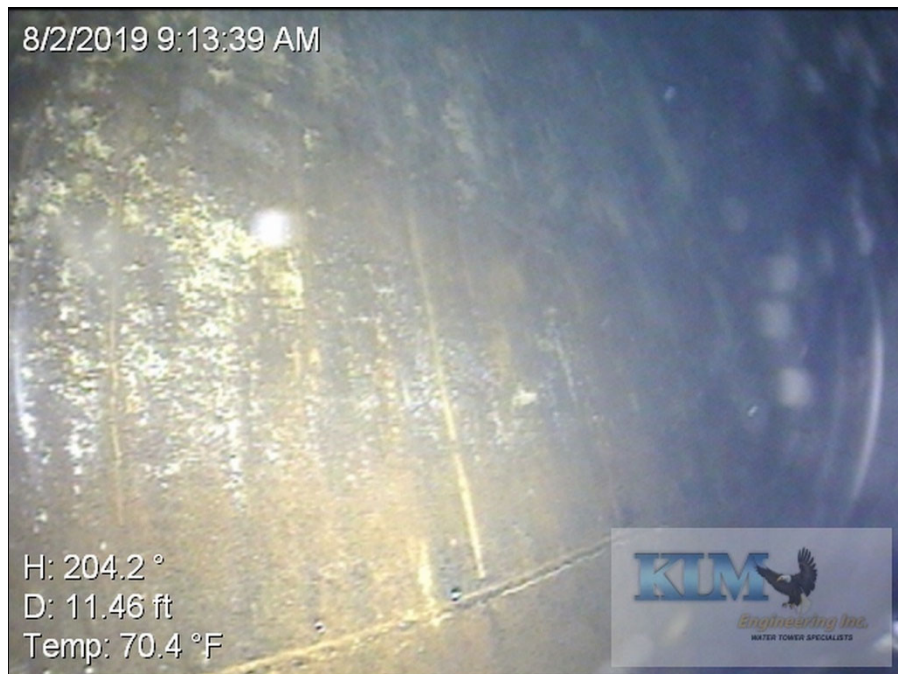
Photo No. 12
Condition of interior wet coating on shell wall
Heavy scale and staining visible; coating blistering and pinhole corrosion along welds

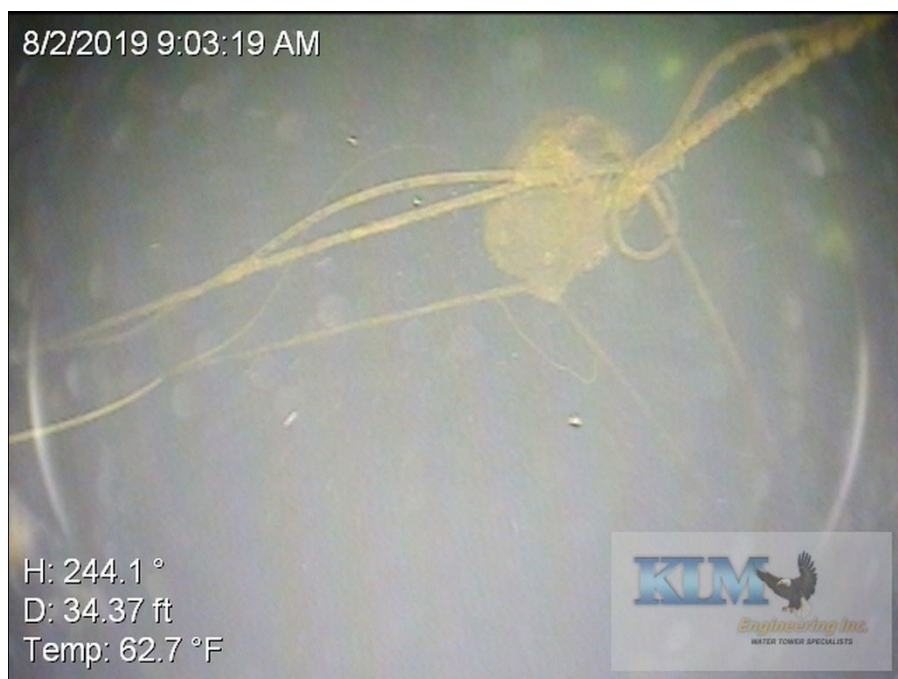
Photo No. 13
Condition of interior wet coating on shell wall
Heavy staining and scale development

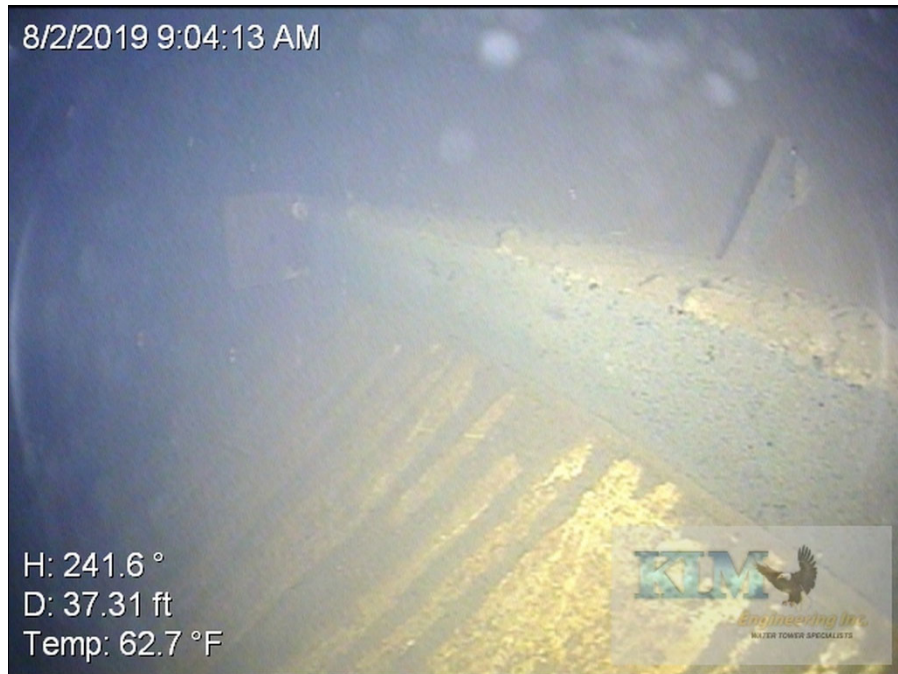
Photo No. 14
Submerged cathodic protection system

- 3.3.1** The reservoir has a submerged C. P. system that is not in working condition and should be removed, see 3.1.5. Although it is considered an inexpensive form of interior corrosion protection, it most likely is not required if the coating is applied and maintained properly. The cost of a new Cathodic Protection System is not included in the Engineer's Cost Estimate.

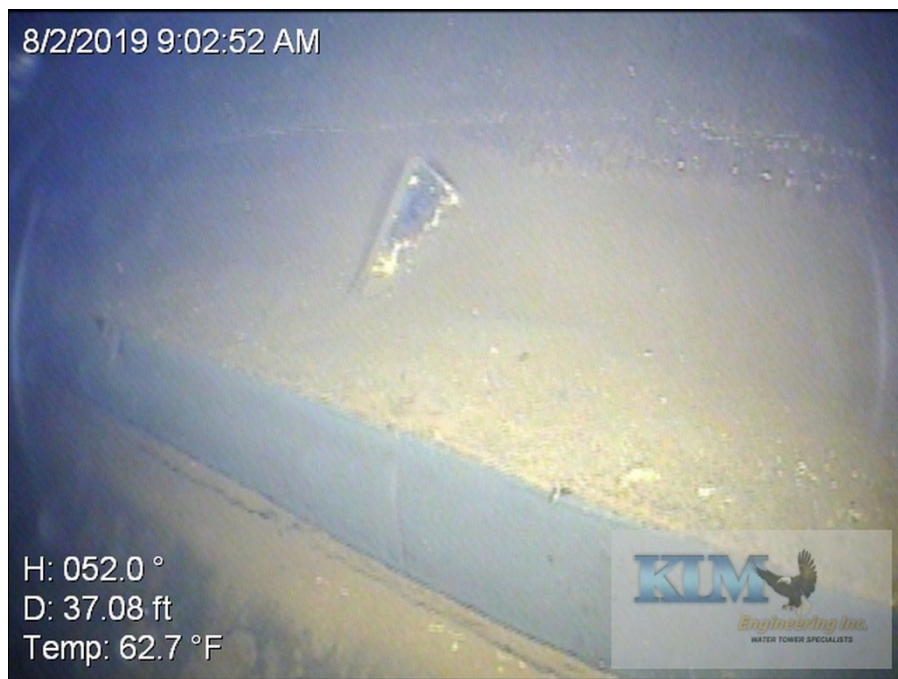
Photo No. 15
Condition of interior wet coating near tension ring
Sediment accumulation and scale formation visible

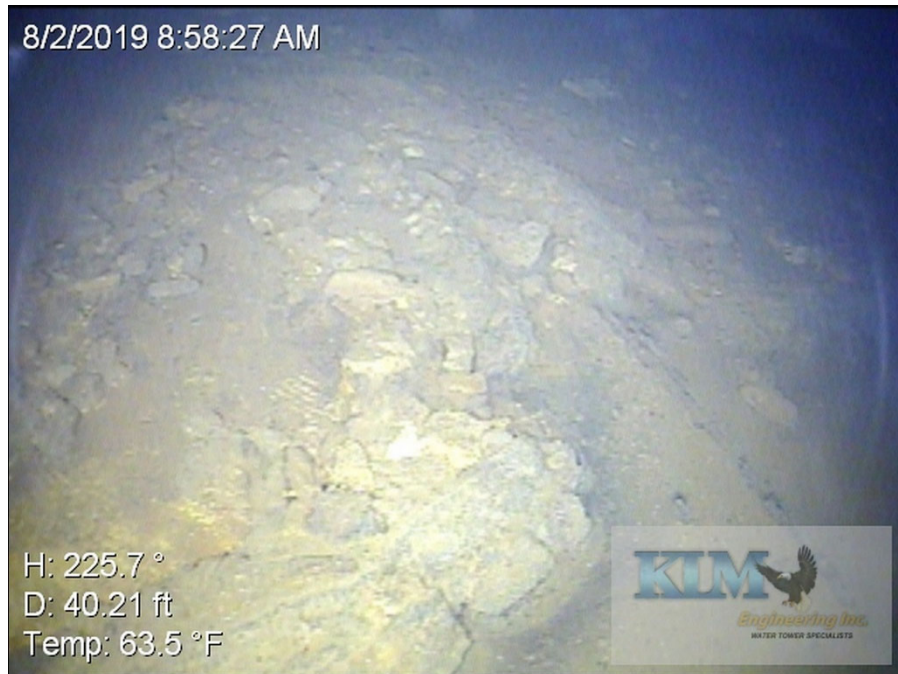
Photo No. 16
Condition of interior wet coating near tension ring
Heavy sediment accumulation visible

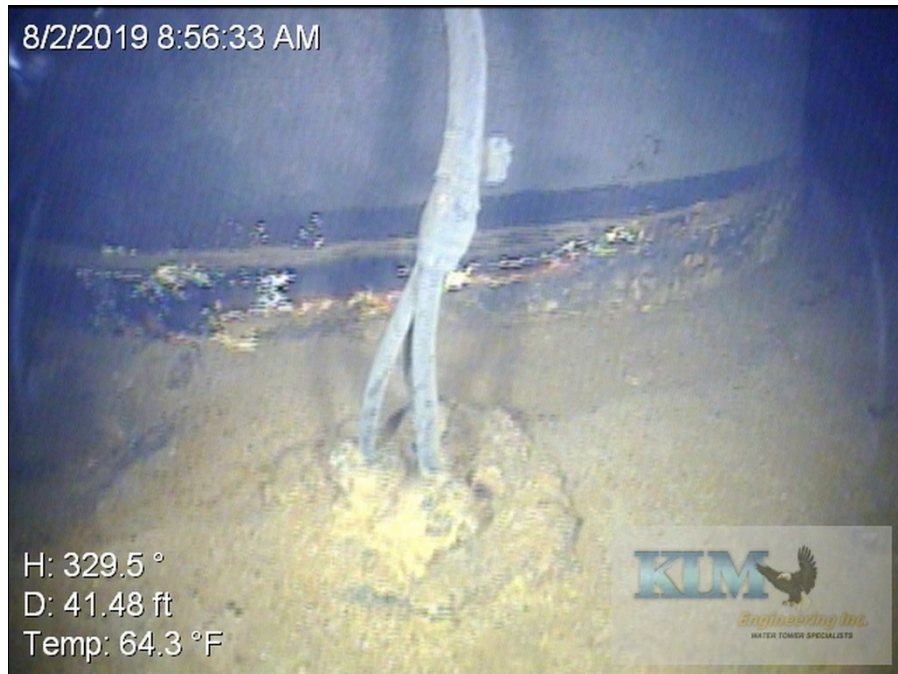
Photo No. 18
Heavy sediment accumulation and scale deposits in bowl
Bowl manway visible

- 3.1.9** Install a davit arm on the existing bowl pressure manway. See KLM Drawing No. 37a and photo 18.
- 3.1.10** Replace the gasket on the 24-inch diameter round bowl manway. See photo 18.

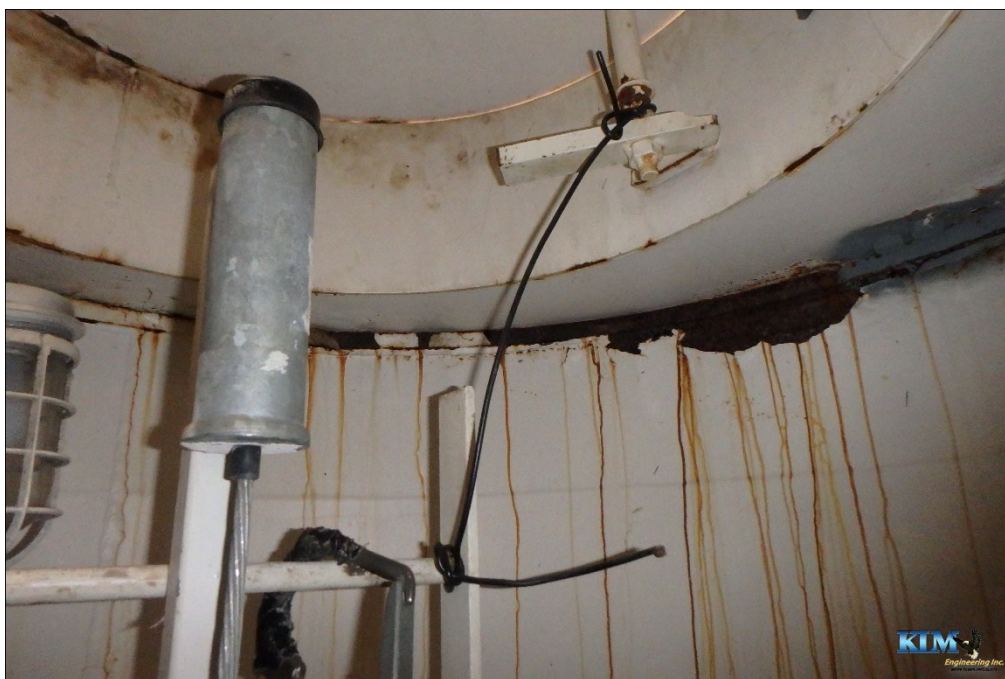
3.5.3 The coating in the drywell tube, on the bowl, and on the platforms should be replaced within the next year. The fluted pedestal should be spot repaired in localized areas but does not need replacement until the following reconditioning in twenty years. See photos 21 through 48.

Photo No. 21
Condition of interior dry coating at top of drywell tube
Significant peeling and surface corrosion occurring

3.5.4 After structural repairs are completed, the surfaces described should be abrasive blasted to an SSPC-SP-6 Commercial Blast Clean and replaced with a zinc/epoxy coating system similar to the Tnemec Series 91-H20 Hydro-Zinc/Tnemec Series N140 Pota-Pox Plus or Sherwin Williams epoxy equivalent.

3.6.2 To prevent trespassing, install a padlock on the roof access manway. Replace the handle on the roof access manway cover to accept a lock. See photos 21 and 22. The cost of a new lock is not included in the Engineering Cost Estimate.

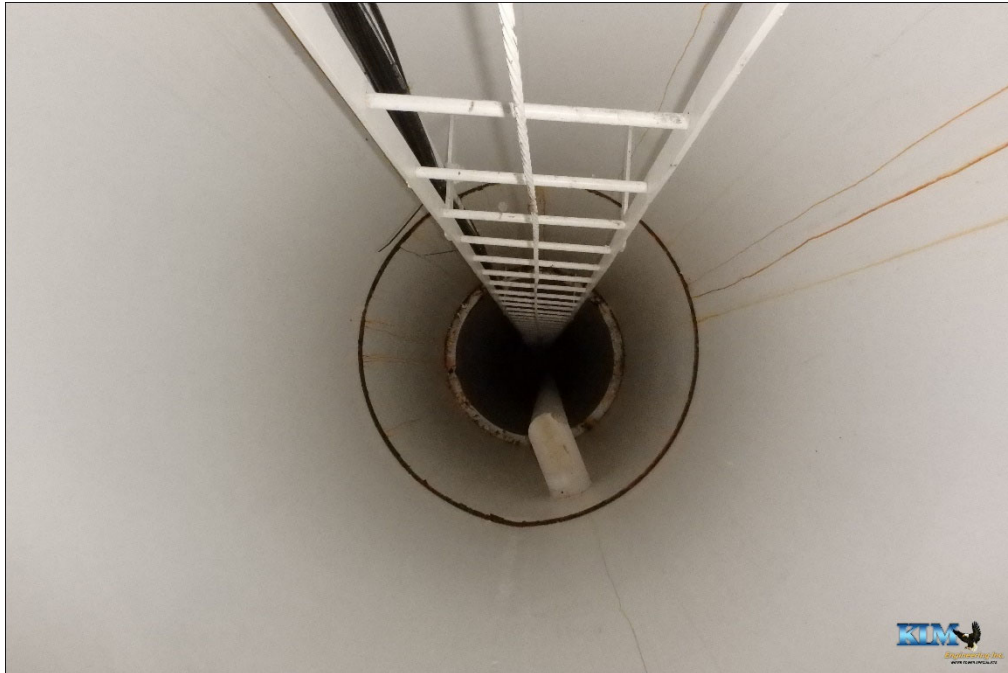
Photo No. 22
Condition of interior dry coating at top of drywell tube
Significant peeling and surface corrosion occurring

- 3.4.1** Replace approximately five (5) existing light fixtures with new LED fixtures similar to the Lithonia Lighting OLVTWM. See photo 22.
- 3.4.2** Replace the cable style safety climb device on the drywell tube ladder with a new OSHA approved cable style climb device. The climb device is currently painted, which does not meet OSHA regulations. See photos 22 through 24, 27, 29, and 36.

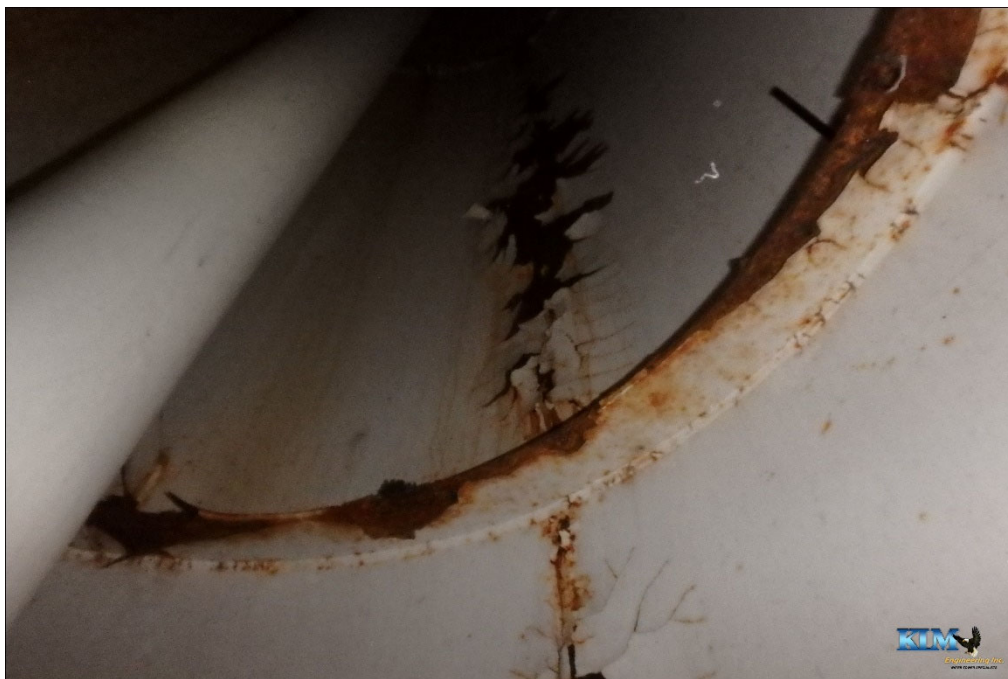
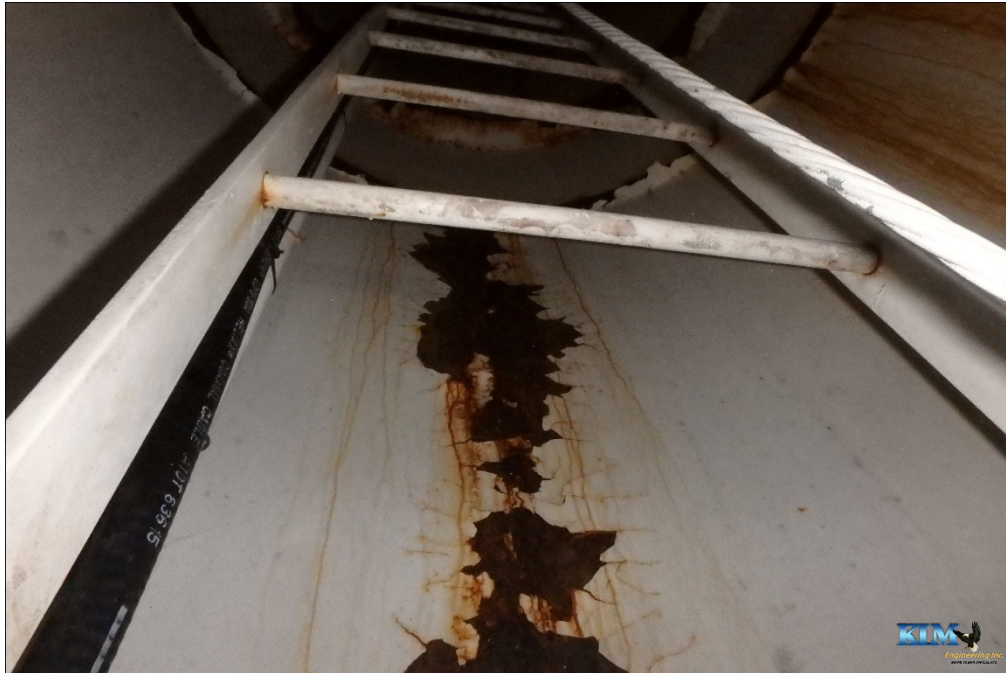
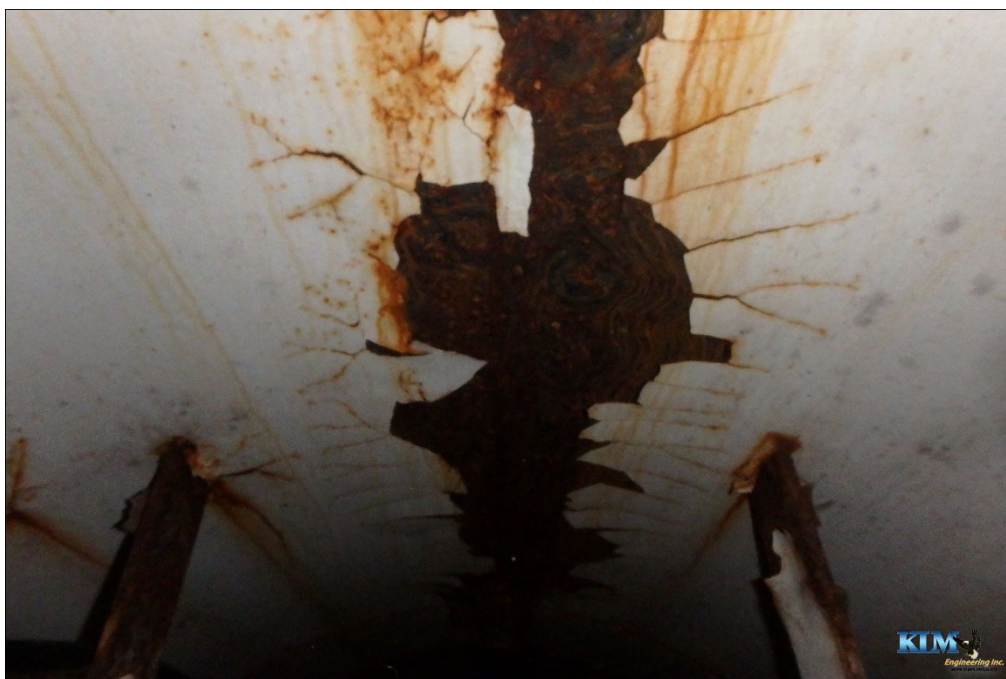
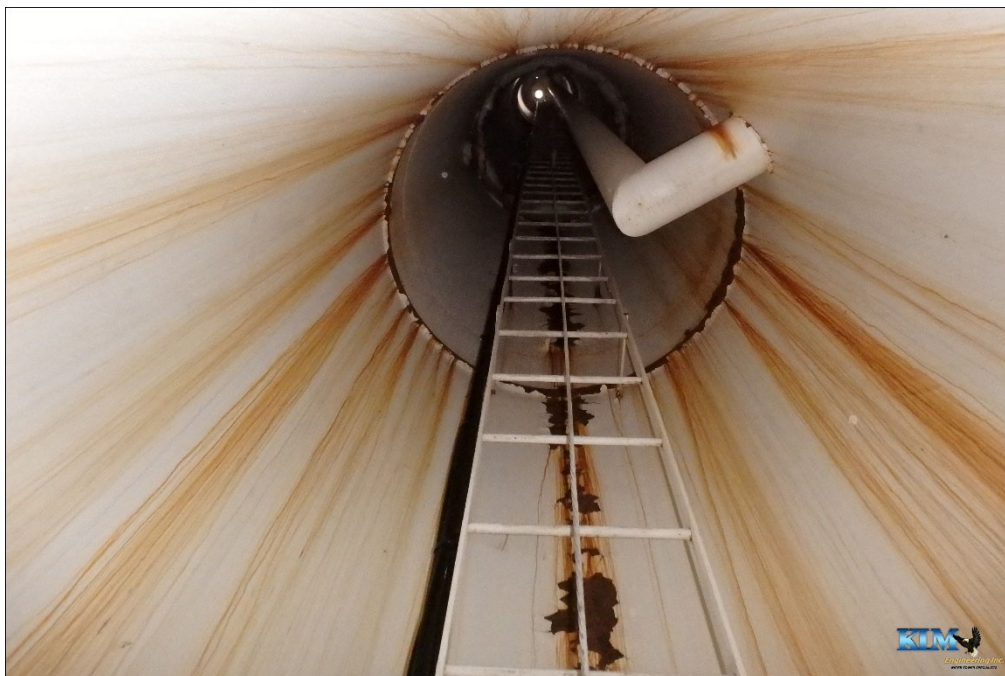
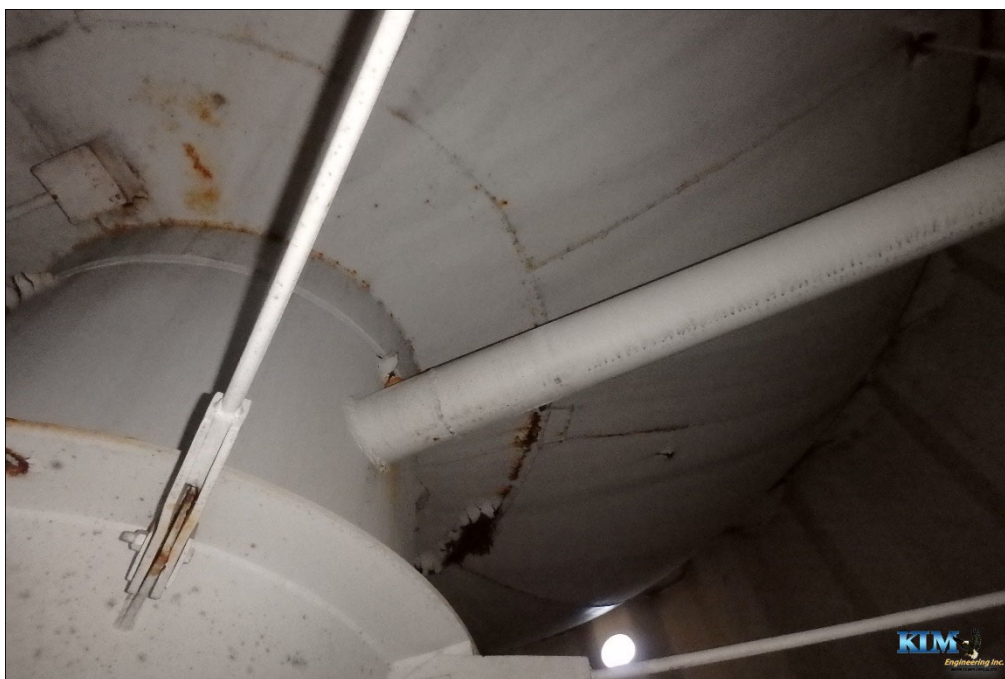
3.5.2 The interior dry coating in the drywell tube, on the bowl, and on the platforms is in poor condition with fifteen (15) to twenty (20) percent visible failures. Moderate surface corrosion is occurring as a result of widespread coating cracking and delamination. Pinhole corrosion can also be found on many of these surfaces.

Photo No. 25
Condition of interior dry coating inside drywell tube
Significant coating peeling and surface corrosion

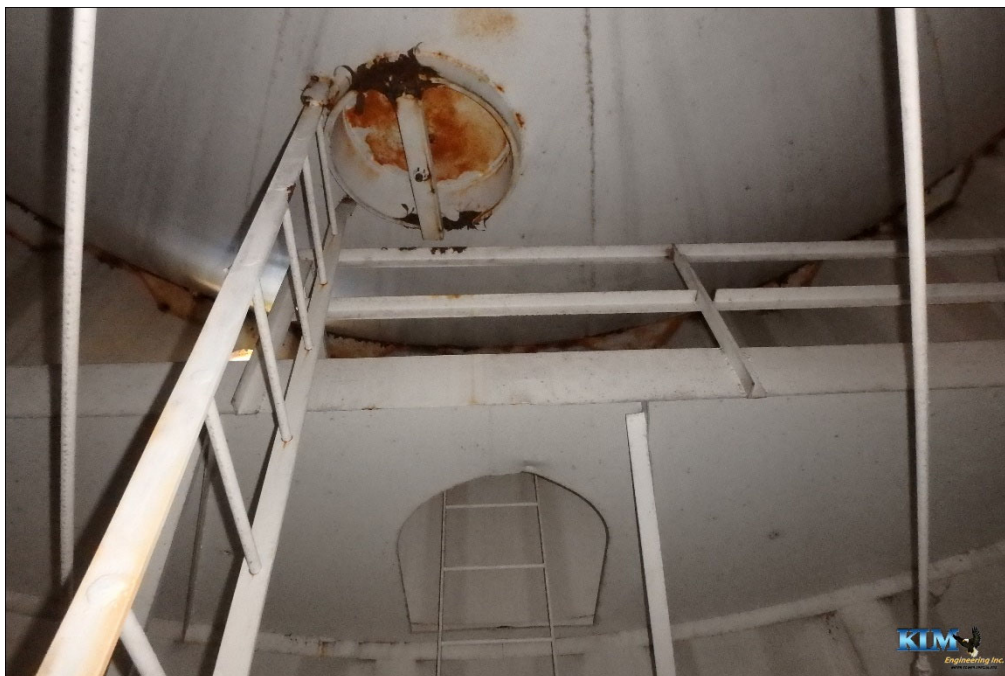
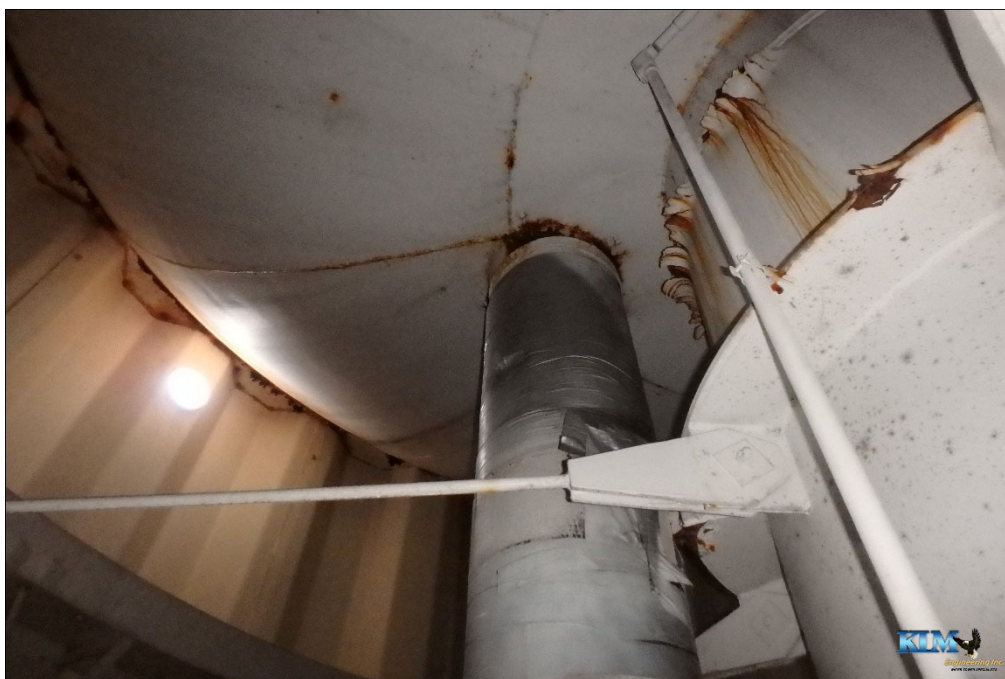
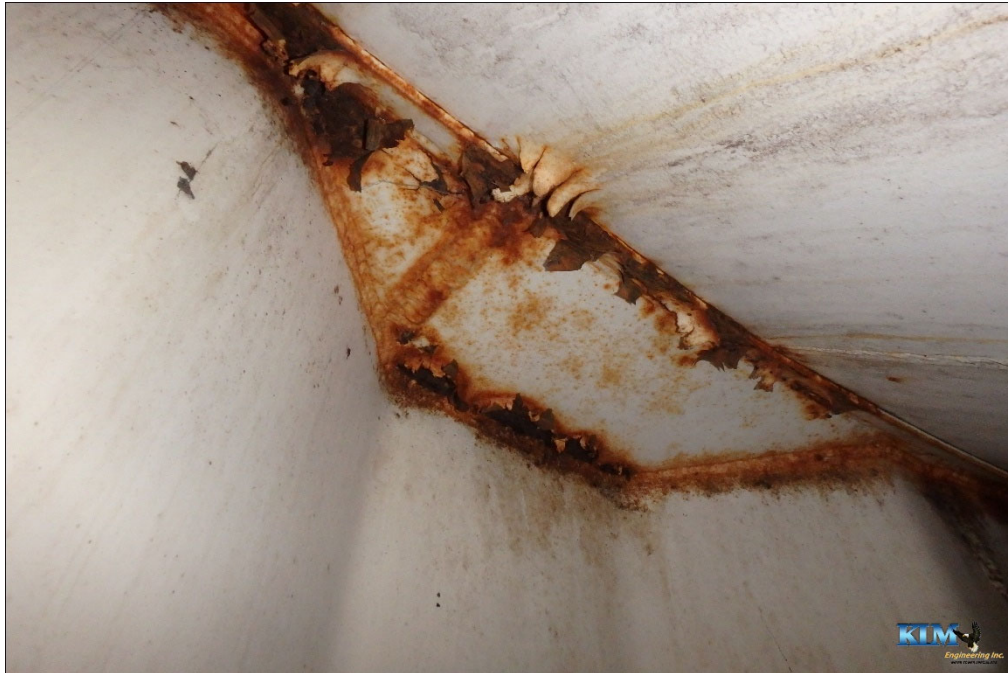
Photo No. 30
Condition of interior dry coating on bowl and drywell tube
Random locations of heavy coating peeling and surface corrosion

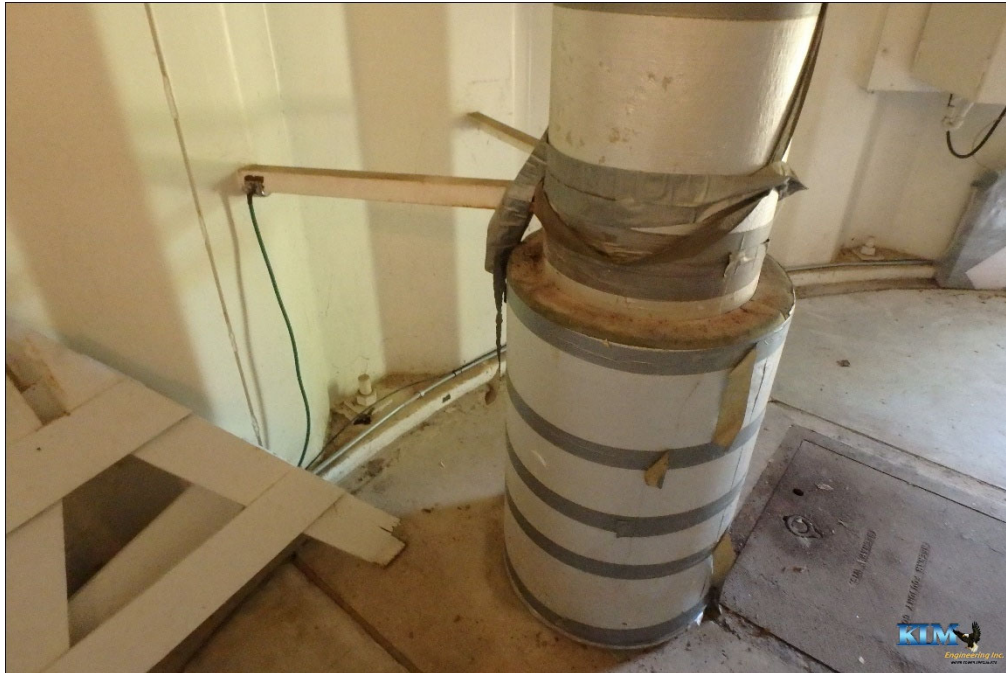
Photo No. 44
Condition of pedestal interior at base
Some missing foil wrap visible

- 3.4.11** Verify the condensate platform drain is free from obstruction. Replace the drainpipe if necessary. See photos 41 and 42.
- 3.4.12** Replace the existing foil wrap around the fill pipe insulation with a protective aluminum jacket. Replace any insulation damaged in the process. See photos 38 through 41, 43 through 46, and 49 and 50.

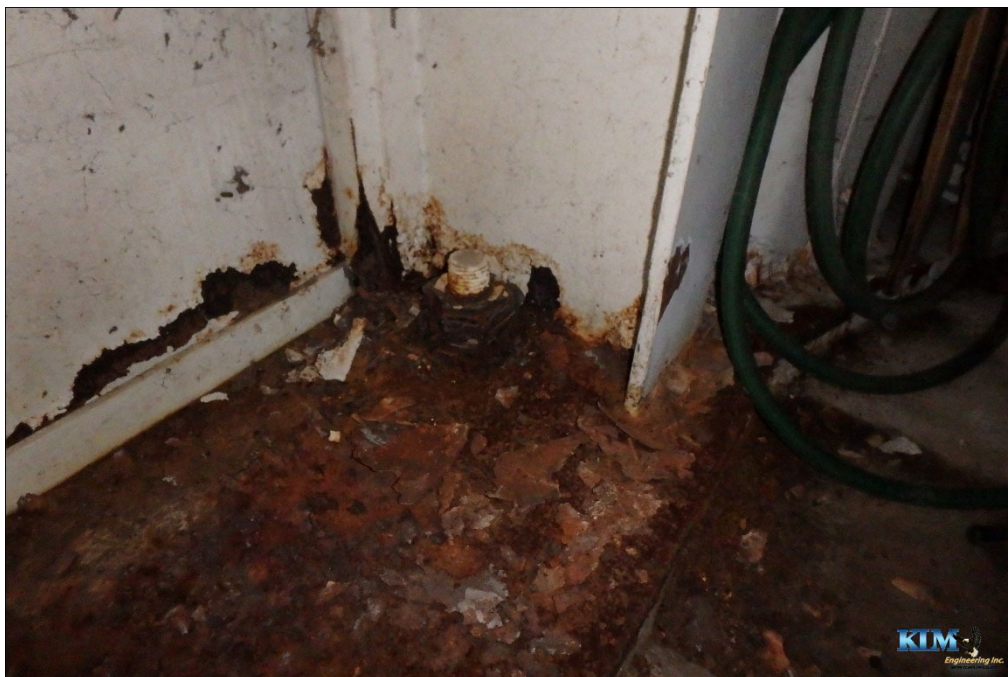
Photo No. 47
Condition of double access doors at base of pedestal
Doors are severely corroded in bottom corners

- 3.6.11** Replace the steel double doors in the base of the pedestal. The doors have corroded through in the corners and need to be replaced. See photos 47 and 61.

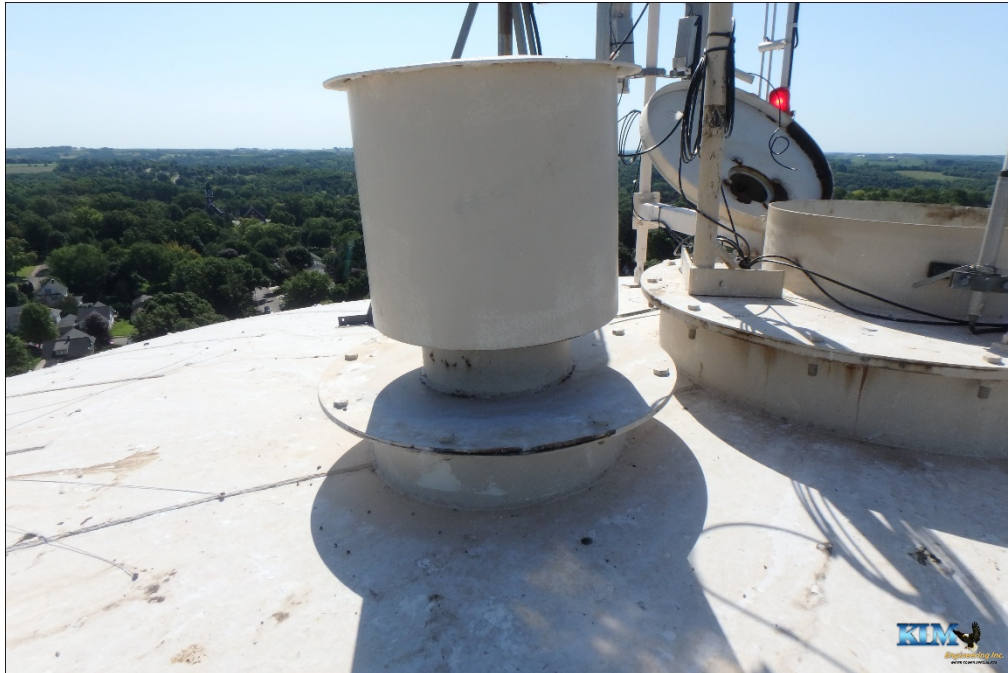
Photo No. 52
Overall view exterior roof condition

- 3.7.2** The exterior coating on the tank is in poor condition with over twenty percent (20) percent visible failures. Failures consist of top and base coat deterioration, exposed steel substrate in numerous locations resulting in spot corrosion, and widespread fade and chalking due to UV expose. A large amount of bird droppings is covering the roof as well. The original coating is assumed to be around 35 years old and surpassed its normal service life. Due to the coating age and condition, the exterior is not a candidate for repairs or an overcoat. The coating should be removed and replaced in its entirety at the same time as the interior wet and dry coatings, within the next year. See photos 52 through 59, 61, and 65.

3.6.1 Replace the drywell tube manway lid with an aluminum style lid. The existing lid is oversized and can be a hinderance to open. Install a stop chain connecting the manway cover at the top of the drywell tube to the manway curb and locking mechanism on the dry side. This will limit the angle of travel of the cover, (prevent the cover from opening 180 degrees), support it while open, and assist climbers in opening and closing the cover. See KLM Drawing No. 11 and photos 52 through 54.

3.6.4 Replace the tank vent/finial with a 24-inch diameter aluminum pressure pallet style vent, similar to the one shown on KLM Drawing No. 8a. See photos 52 and 53. The new vent and vent screen design should meet AWWA D100-11 and local Health Department Regulations. The removable top will improve ventilation, provide access to the tank interior during reconditioning, and aid in compliance with OSHA Confined Space Entry Requirements.

- 3.6.8** Remove the non-functional bird deterrent devices from the roof. See photo 55.
- 3.6.9** Replace the double aviation light with a new double LED style aviation light similar to Hughey & Phillips L-810 and relocate to a mount on the newly installed handrail. Remove the existing mount and repair surface as required. Modify/replace electrical conduits and wiring as necessary. See photos 52 through 54.

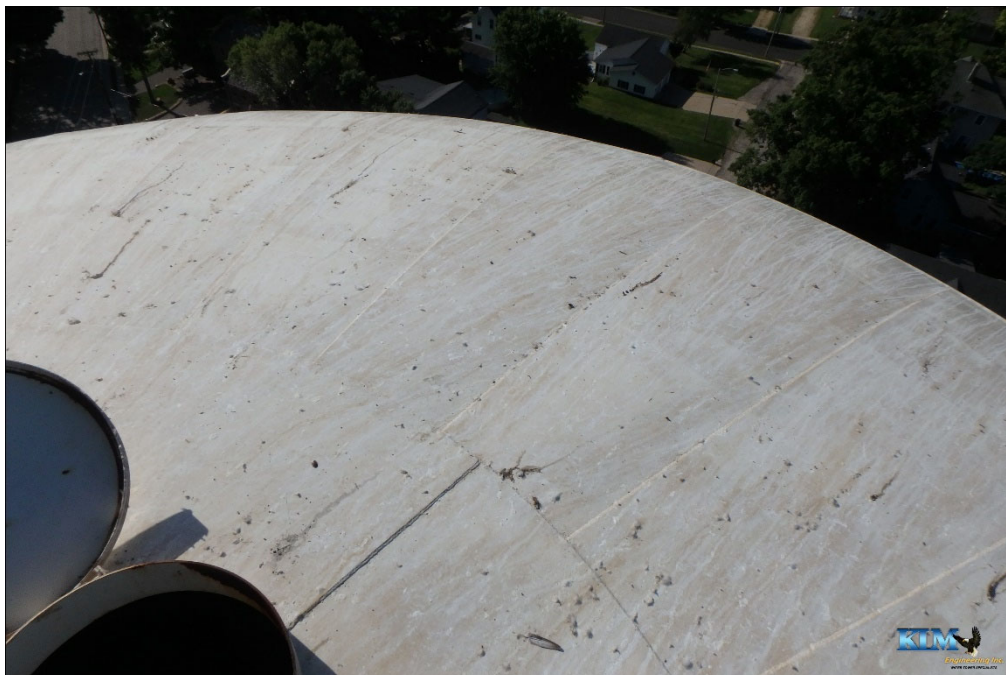
Photo No. 55
Condition of exterior coating on roof
Bird droppings covering roof; non-functional bird deterrent visible

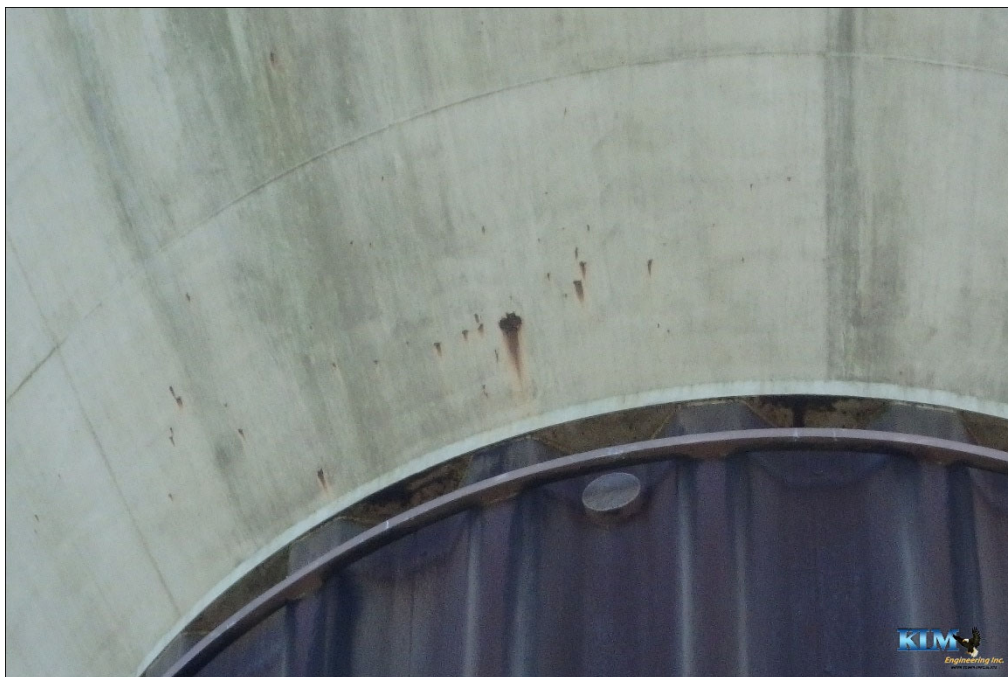
Photo No. 57
Overall condition of exterior coating on side of tank
Heavy organic growth on lower half of tank

- 3.7.2** After structural repairs are completed, the exterior coated surfaces should be abrasive blasted to an SSPC-SP6 Commercial Blast Clean and replaced with a zinc/epoxy/urethane/fluoropolymer coating system (similar to the Tnemec Series 91-H20 Hydro-Zinc/Series N140 Pota-Pox Plus Epoxy/Series 73 Endurashield/Series 701 Hydroflon coatings).

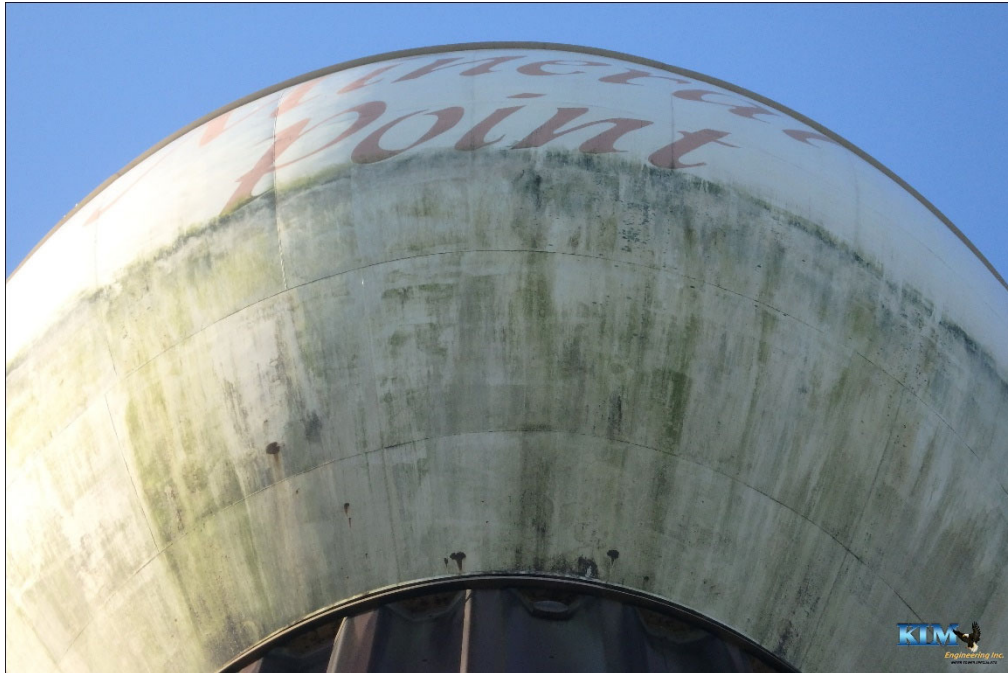
Photo No. 58
Condition of exterior coating near base of tank
Spot and surface corrosion visible

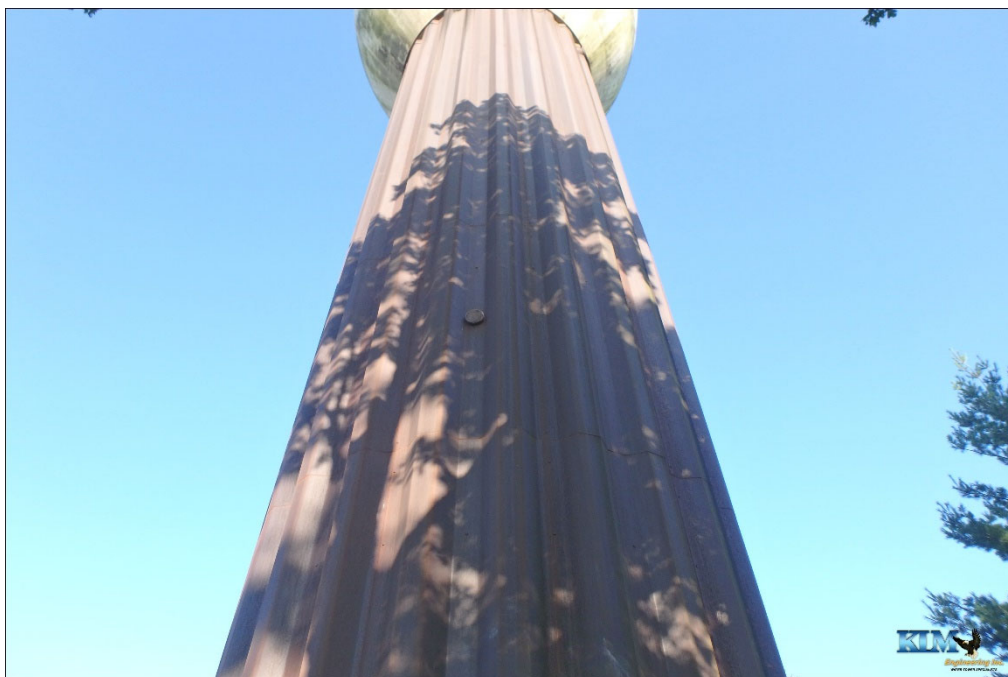
Photo No. 59
Condition of exterior coating near base of tank
Spot and surface corrosion visible

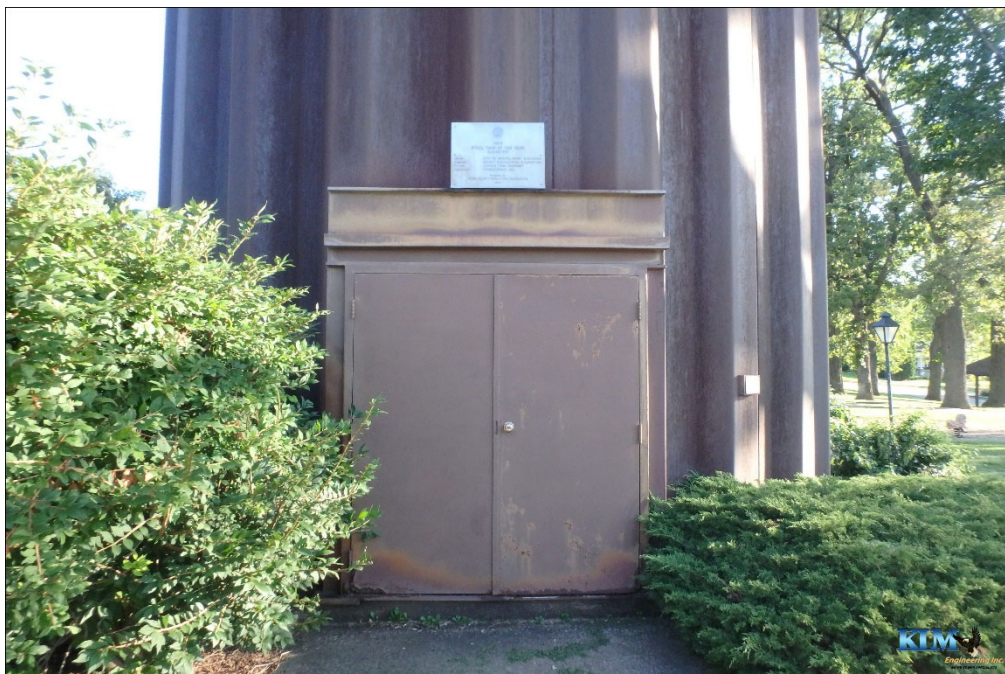
- 3.7.1** The tower pedestal is a unique material not commonly found in water tower construction. It is constructed of weathering steel, or commonly referred to as COR-TEN steel, that is intended to remain uncoated and create a self-developing protective layer of mild corrosion. The mild corrosion layer is what gives the pedestal its current rust coloration. The pedestal steel appears to be in good condition with no repairs required.

Photo No. 60
Condition of uncoated COR-TEN steel pedestal

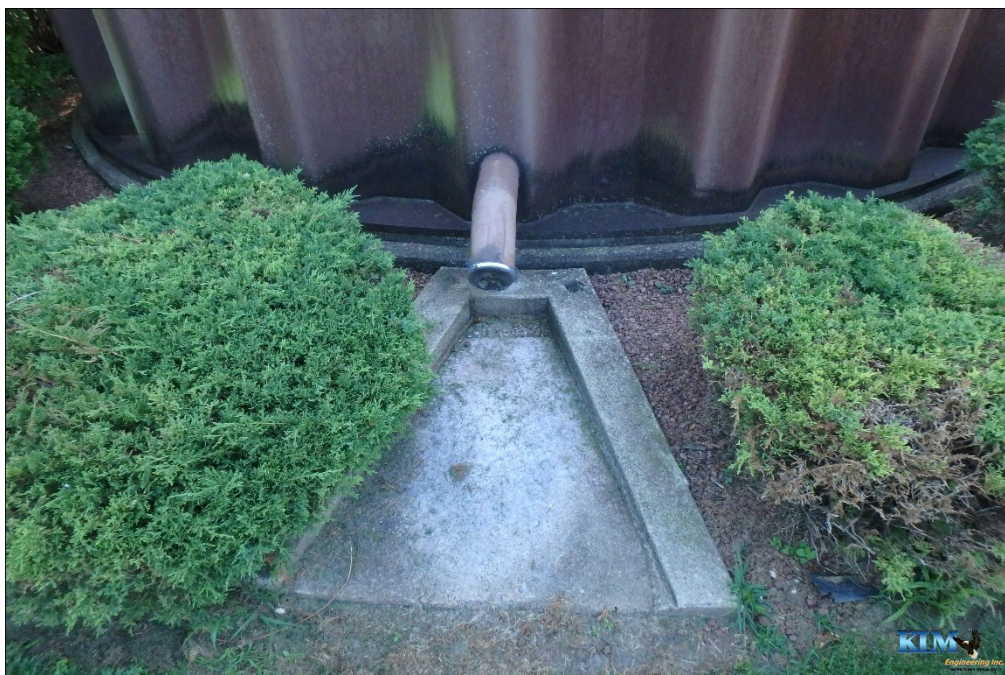
Photo No. 61
Condition of uncoated COR-TEN steel pedestal at base
Double access doors significantly corroded at bottom corners
