CITY OF MINERAL POINT, WISCONSIN

400,000 Gallon Capacity
Tower Number One - Hydropillar

Elevated Water Tank Inspection Report

KLM Project
MN3961

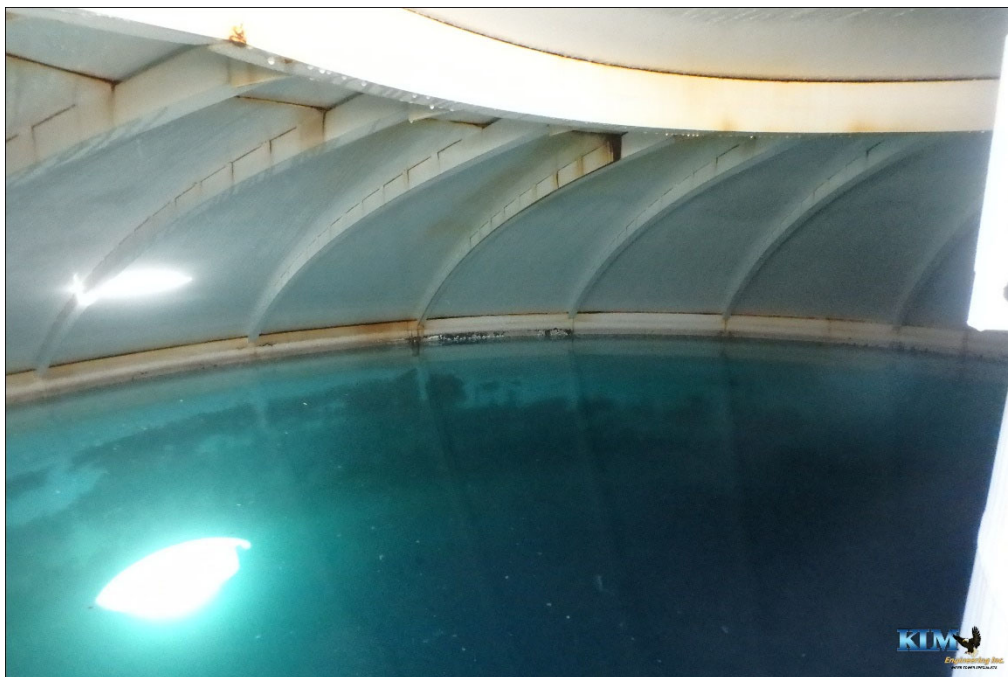
The interior wet coating above the high-water line (HWL) is in fair condition with approximately five (5) percent visible coating failures. The failures are located predominantly in difficult to coat locations such as along roof plate seams, where the roof rafters meet the roof plates, above the compression ring, and around the roof hatches and drywell tube welds. Staining from these failures is visible on many of the surfaces but doesn't affect the coating performance.

Photo No. 2
Overall condition of interior wet coating above HWL

- 3.2.3** Overall, the interior wet coating is in fair condition. Due to the age of the coating, it is not considered repairable and has far outlived a typical coating service life. Typical service life of a properly maintained coating is generally 20 to 25 years. The coating should be replaced within the next year. See photos 2 through 13, 15, 16, and 18 through 20.

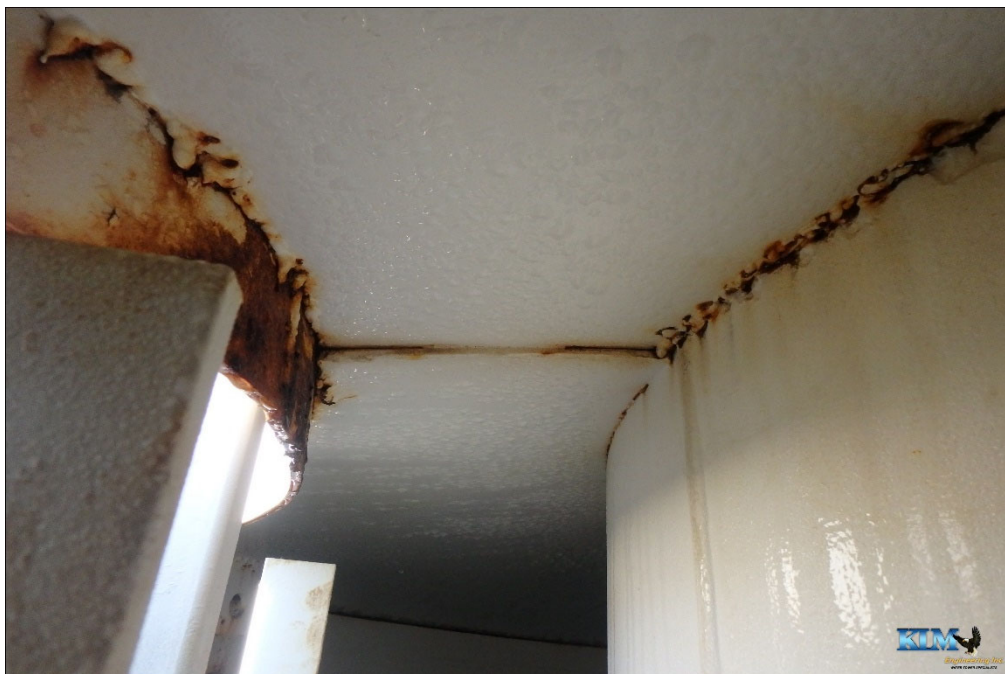
Photo No. 5
Condition of interior wet coating around drywell tube and manway access

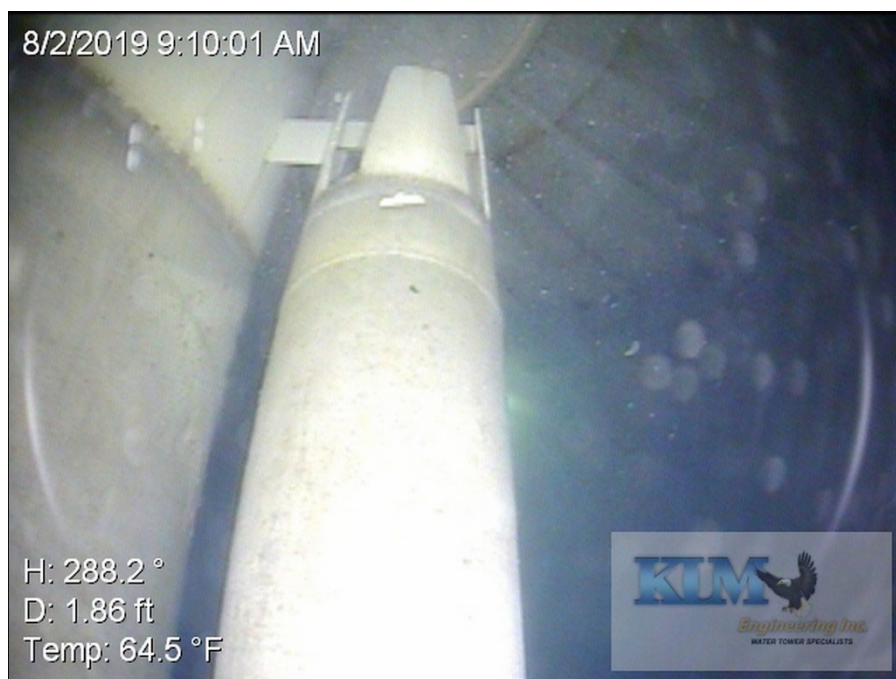
Photo No. 6
Condition of top of overflow pipe; view from below HWL

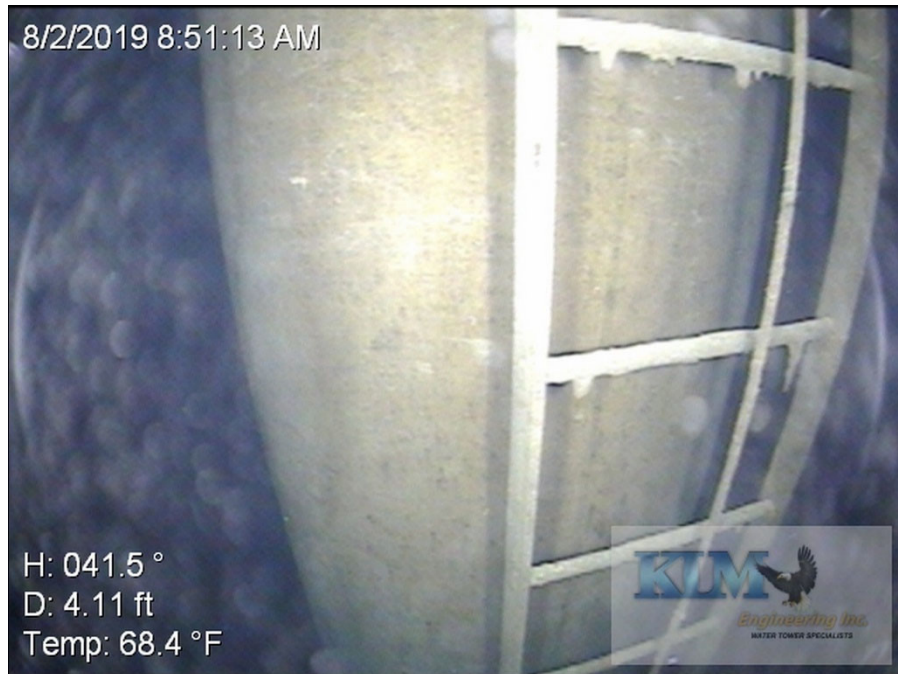
Photo No. 7
Condition of interior wet coating on drywell tube below HWL

3.1.4 Remove the existing cable safety climb device from the interior wet ladder. Install an anchor point and Self-Retracting Life-Line (SRL) to allow for safe access while ascending and descending the ladder. Refer to KLM Drawing No. 26. See photo 7.

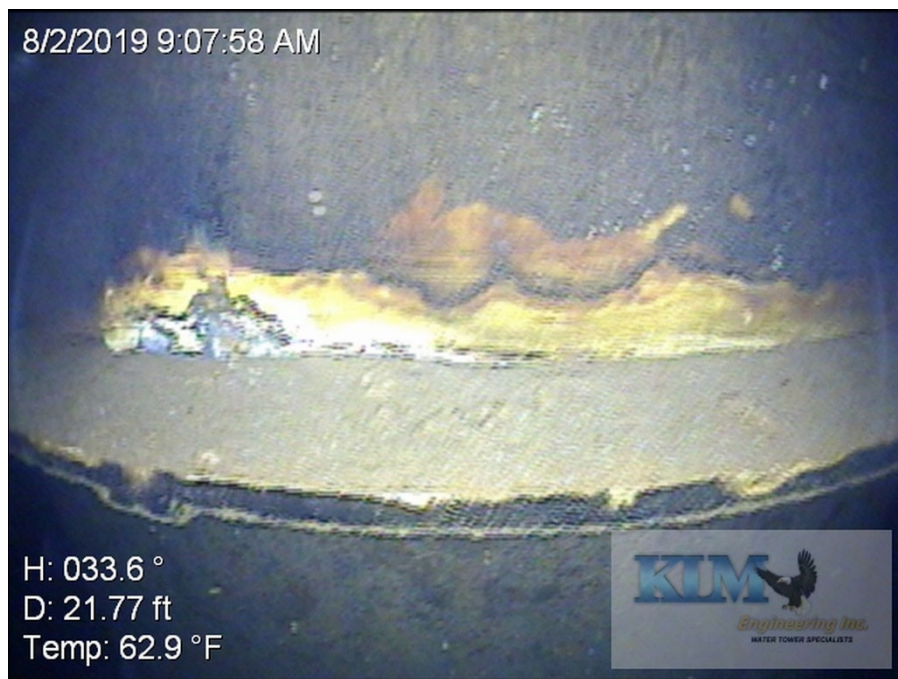
Photo No. 8
Condition of interior wet coating on drywell tube at stiffener ring
Rust coloration due to corrosion

- 3.1.6** Seal weld the joint between the stiffener rings and the drywell tube to comply with AWWA D100-11. See photos 8 and 9.
- 3.1.7** Remove all weld spatter and scab marks below the HWL by air arc gouging, cutting torch, and/or grinding to comply with AWWA D100-11. Prepare the surface per Appendix C. It is estimated that there are 50 man-hours to perform the work. See photos 11 and 12.

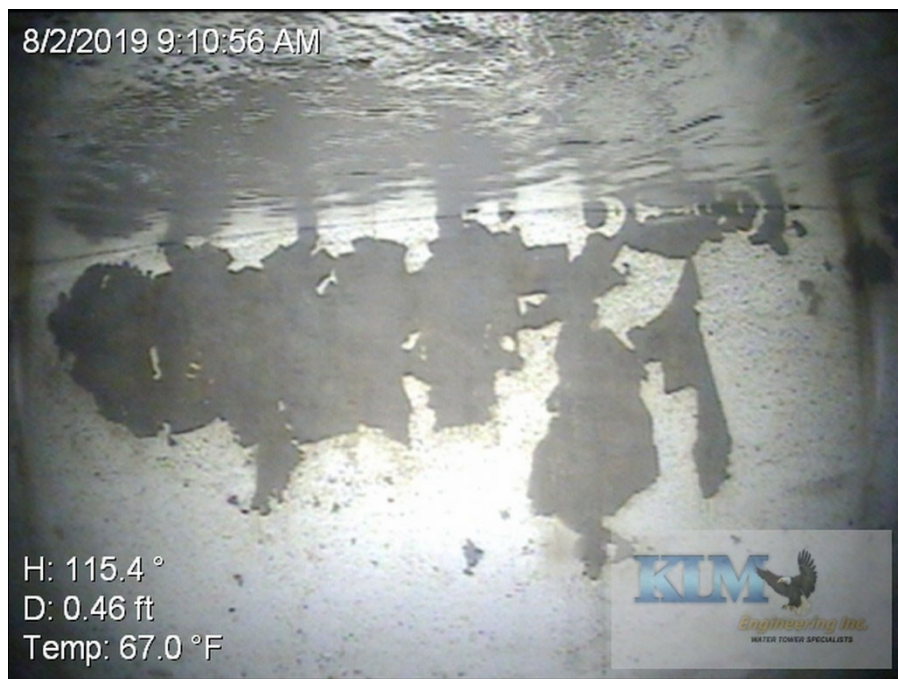
Below the HWL, the condition of the interior wet coating is very difficult to assess. A significant amount of scale, staining, sediment, and deposits exist on the tank shell. The estimated coating failures is approximately five (5) percent. Visible failures consist of blistering around random weld seams, pinhole corrosion, and coating delamination. Sediment accumulation is estimated to be one (1) to two (2) yards.

Photo No. 10
Condition of interior wet coating just below HWL
Dark scale formation on shell

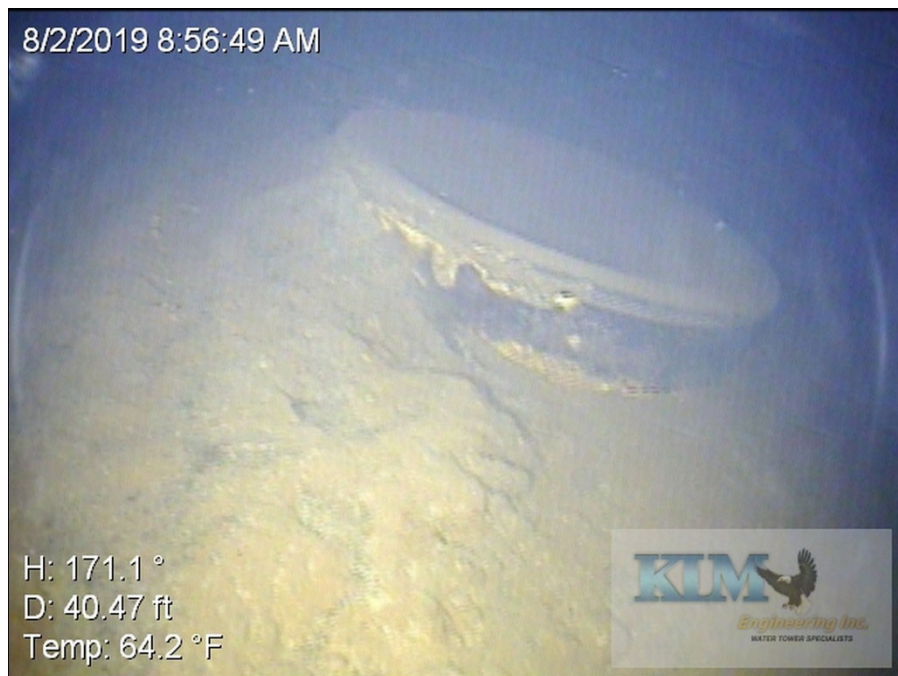
Photo No. 18
Heavy sediment accumulation and scale deposits in bowl
Bowl manway visible

- 3.1.9** Install a davit arm on the existing bowl pressure manway. See KLM Drawing No. 37a and photo 18.
- 3.1.10** Replace the gasket on the 24-inch diameter round bowl manway. See photo 18.

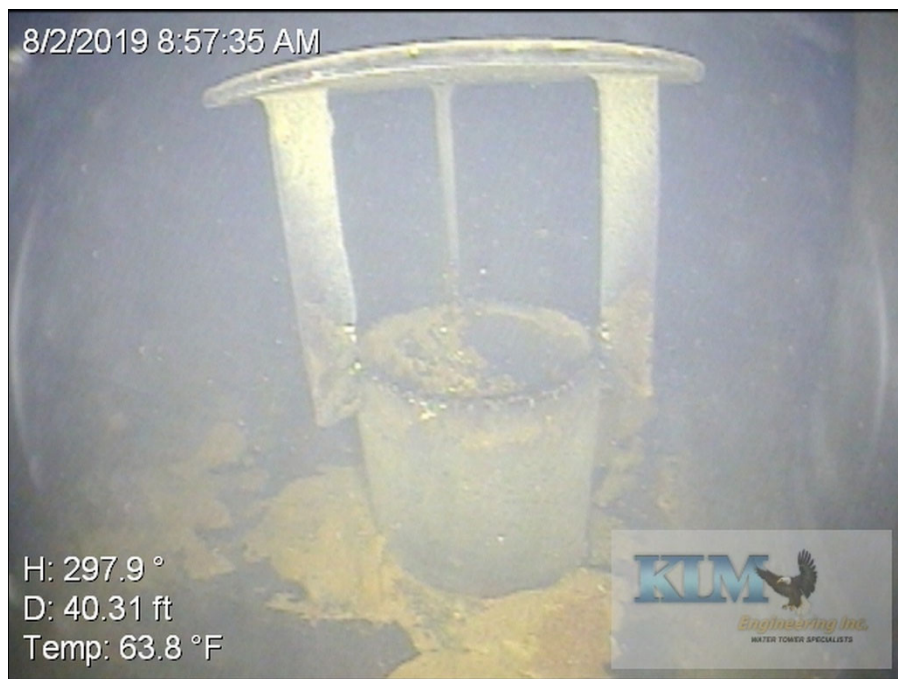
Photo No. 20
Condition of fill pipe in bowl
Sediment accumulation visible around pipe

- 3.1.11** Install two (2) bars on top of the fill pipe to hinder materials from falling into the pipe. See photo 20.
- 3.1.12** Install a Grid-Bee GS-9 Submersible Mixer in the tower to provide mixing capabilities that reduce the likelihood and magnitude of ice formation in cold weather and prevent stratification in warm weather, improving water quality and reducing the necessity of chemical additives such as chlorine. Refer to KLM Drawing 63.

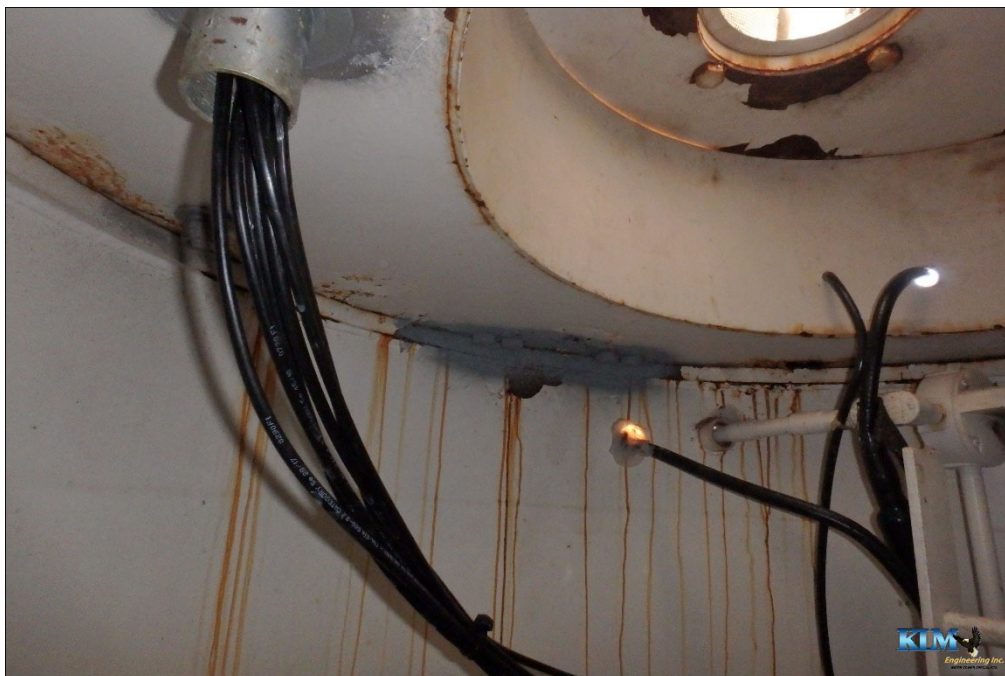
Photo No. 21
Condition of interior dry coating at top of drywell tube
Significant peeling and surface corrosion occurring

- 3.4.4** Install approximately eight (8) half-moon cable brackets inside the drywell tube, equally spaced, for the attachment of electrical and coaxial cables. Remove all unused clamps, brackets, etc. Move cables and conduit from the side of the ladder to the cable brackets to bring the ladder into OSHA compliance. See KLM Drawing No. 4a and photos 21 through 29.

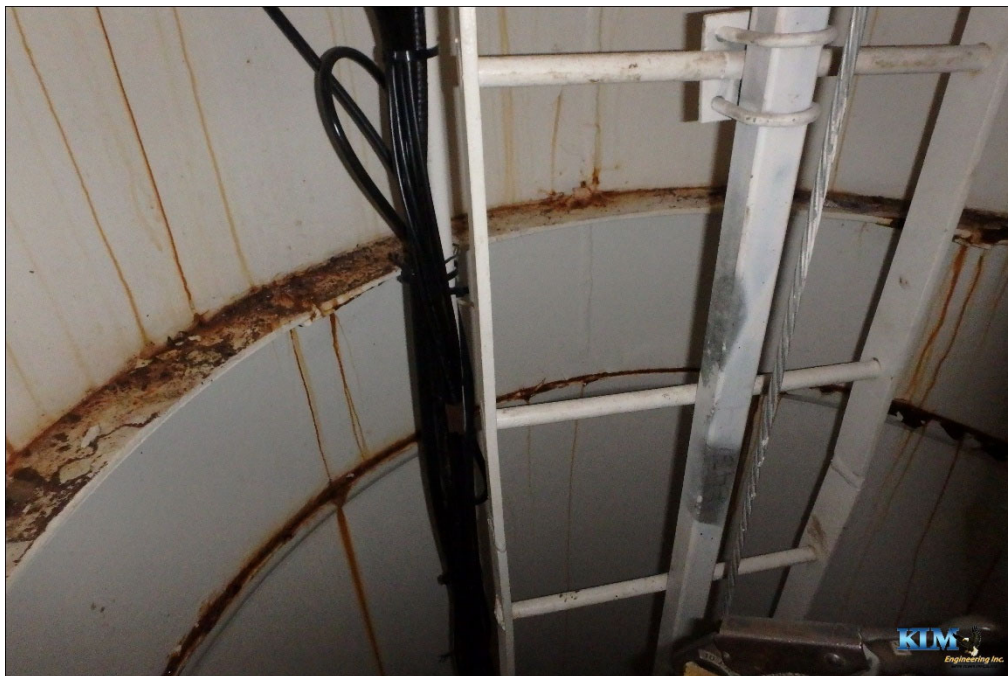
Photo No. 24
Condition of interior wet coating inside drywell tube

- 3.4.8** Seal weld approximately five (5) lap seams on the dry side of the drywell tube. Refer to photos 24 and 29.
- 3.4.9** Seal weld the top side seams of the plates making up the condensate ceiling floor and remove rigging tab. See photos 39 and 41.

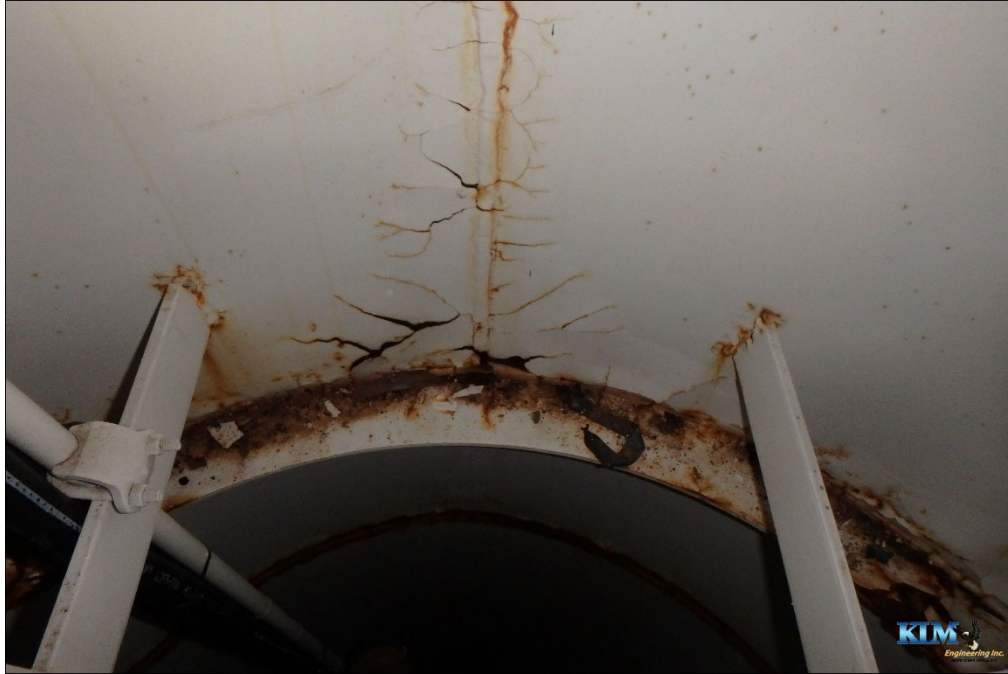
Photo No. 25
Condition of interior dry coating inside drywell tube
Significant coating peeling and surface corrosion

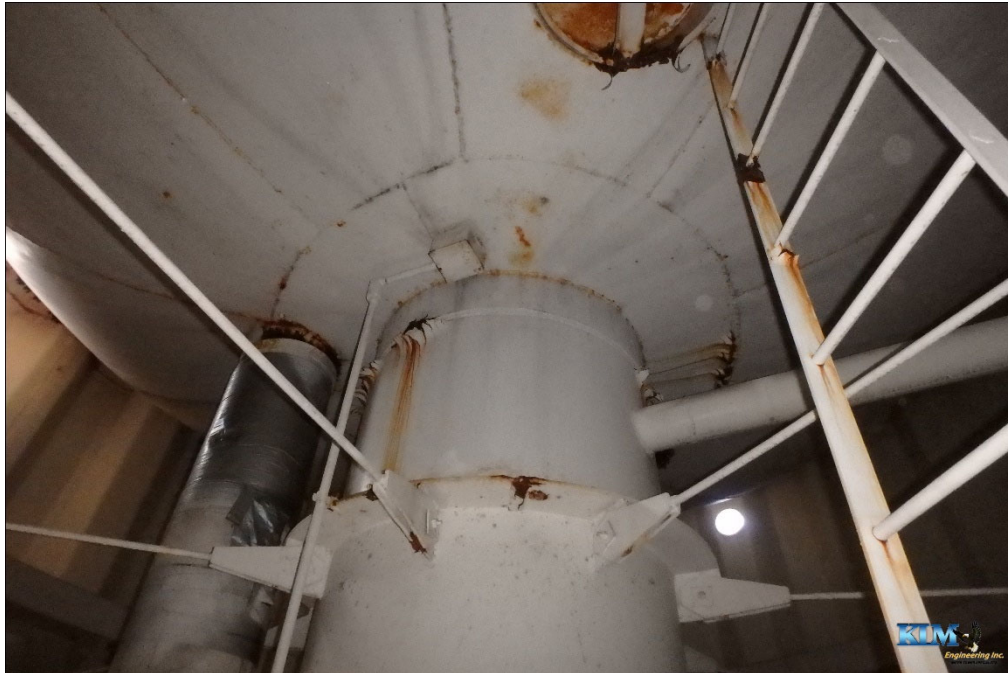
Photo No. 35
Overall condition of interior dry coating at bowl platform

- 3.4.6** Install a new stainless-steel bowl drain valve similar to those designed by General Construction or Babco Valves. Include a clear, rigid, high pressure hose connected to the overflow pipe. Include the installation of a new heavy-walled coupling in the bowl. This will facilitate cleaning and draining the bowl below the inlet pipe level. Install a hand hole in the drywell tube for access to the new valve from the drywell tube ladder. See KLM Drawing No. 33 and photo 35.

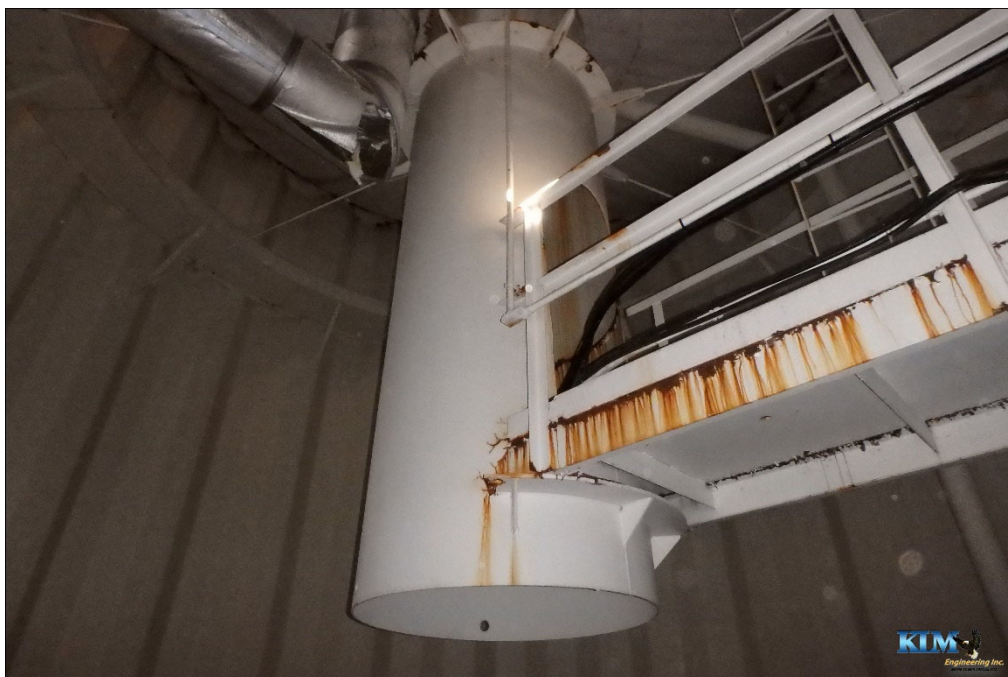
Photo No. 38
Condition of interior dry coating on drywell tube and platform

- 3.4.11** Verify the condensate platform drain is free from obstruction. Replace the drainpipe if necessary. See photos 41 and 42.
- 3.4.12** Replace the existing foil wrap around the fill pipe insulation with a protective aluminum jacket. Replace any insulation damaged in the process. See photos 38 through 41, 43 through 46, and 49 and 50.

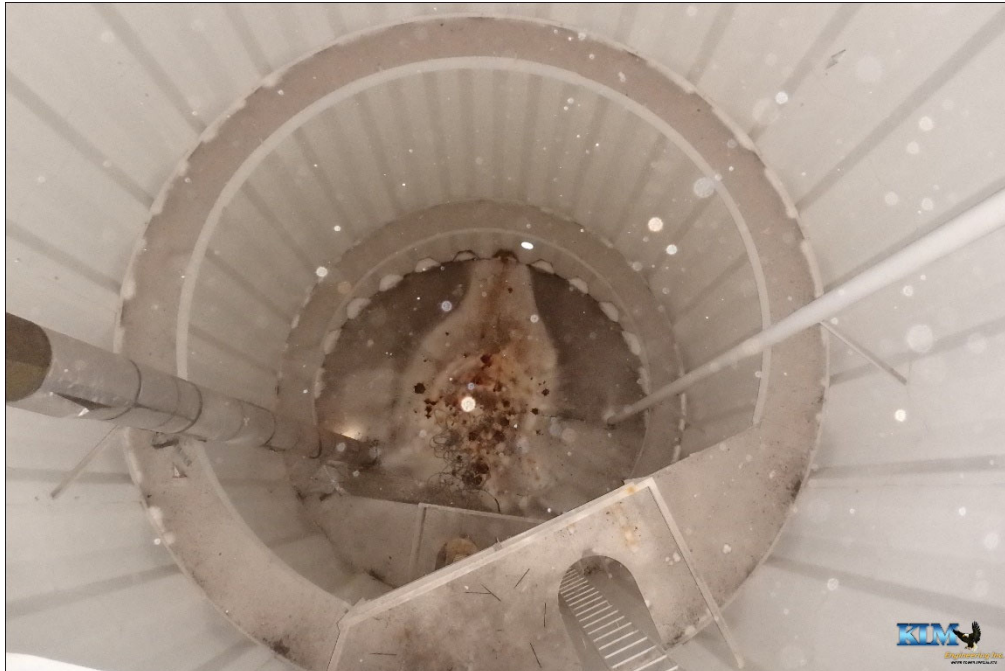
Photo No. 39
Condition of interior dry coating inside pedestal
View looking down pedestal to condensate ceiling below

- 3.4.7** Install approximately ten (10) pedestal stand-off brackets in the pedestal at 8-foot maximum spacing for the mounting of the electrical and coaxial cables. Move the electrical conduits along the ladders to the stand-off bracket to bring the ladders into OSHA compliance. See KLM Drawing No. 4b and photos 39, 40, 44, and 46.

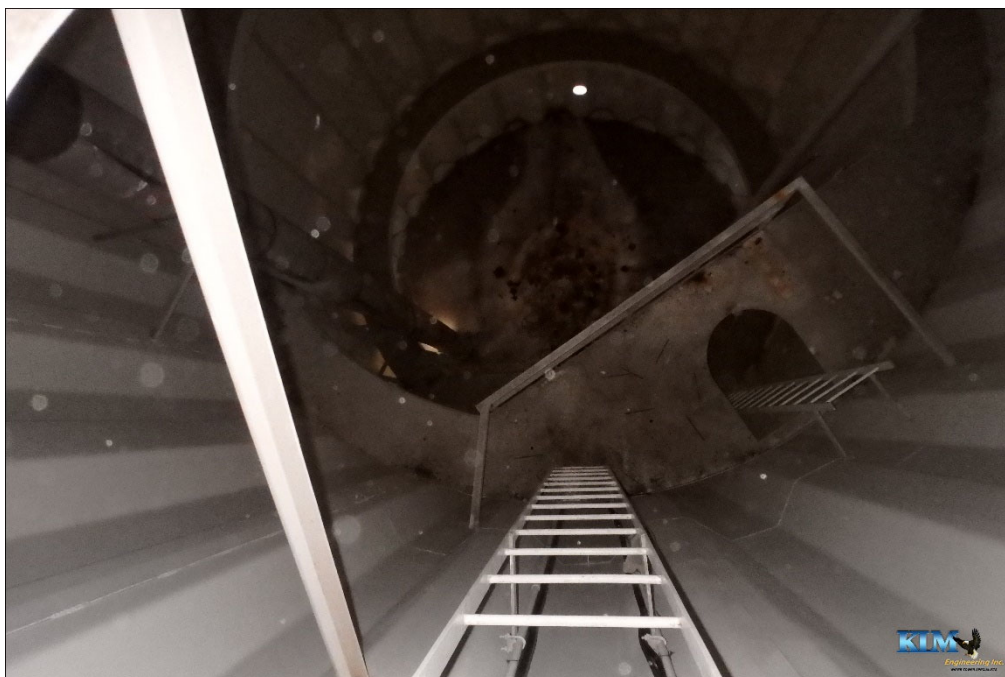
Photo No. 40
Condition of access ladders and wall coating inside pedestal

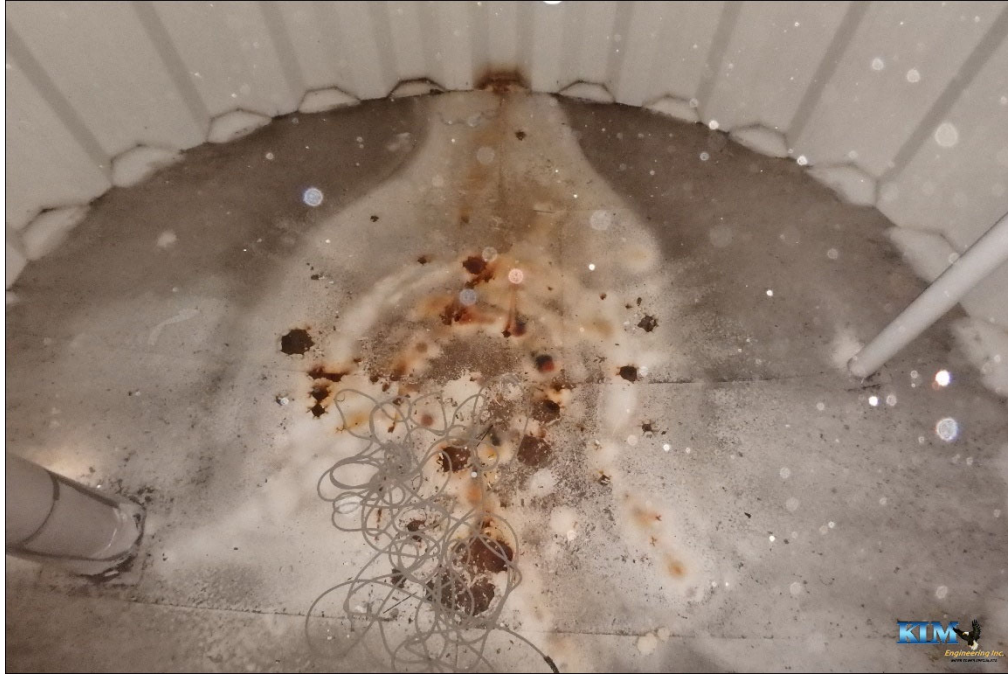
Photo No. 41
Condition of interior dry coating on condensate platform

- 3.4.10** Install a port in the center of the condensate platform floor and bottom of the drywell tube to facilitate containment during the next reconditioning. See KLM Drawing No. 45 and photos 36, 41 and 46.

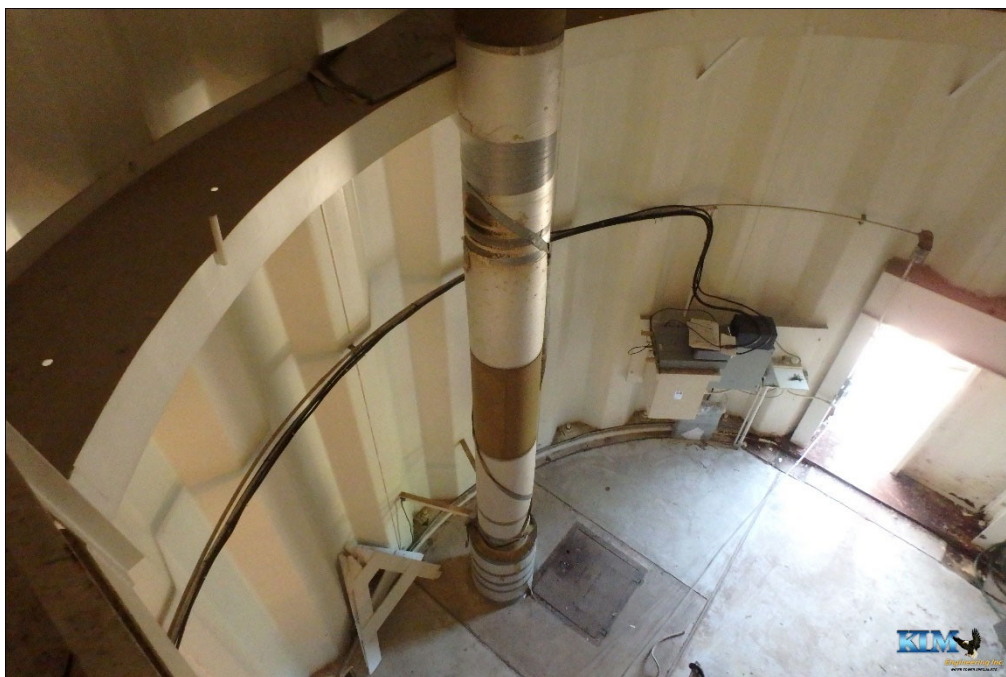
Photo No. 44
Condition of pedestal interior at base
Some missing foil wrap visible

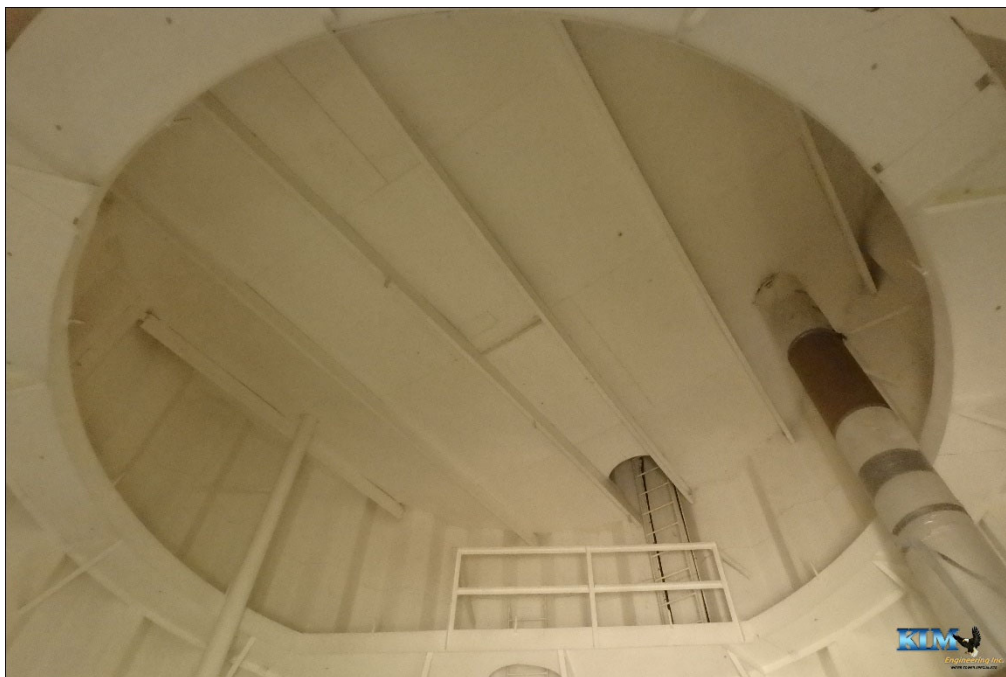
Photo No. 46
Condition of interior dry coating on bottom of condensate platform

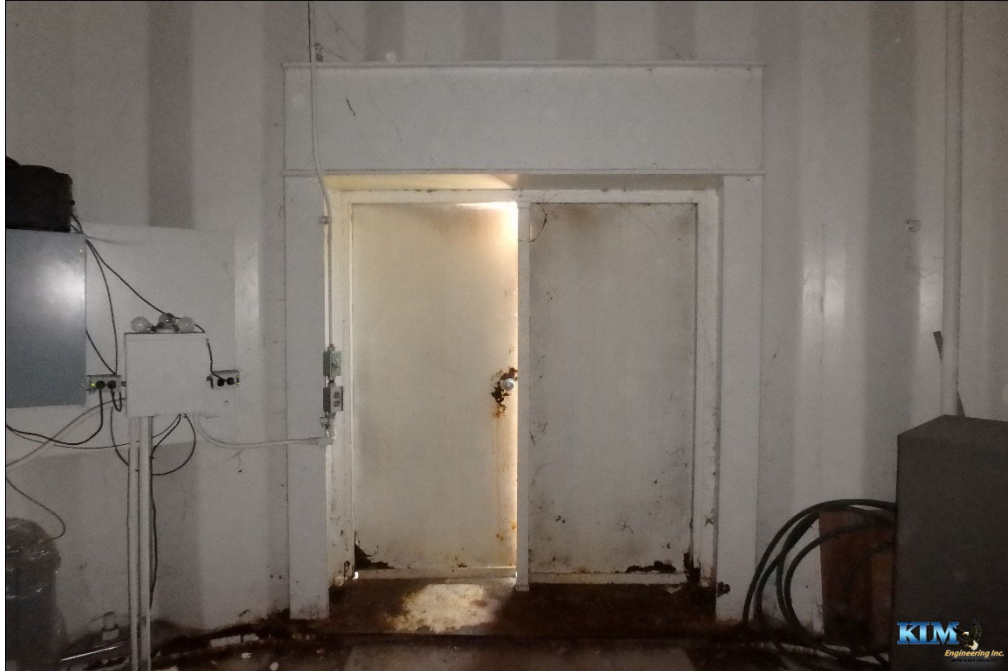
Photo No. 47
Condition of double access doors at base of pedestal
Doors are severely corroded in bottom corners

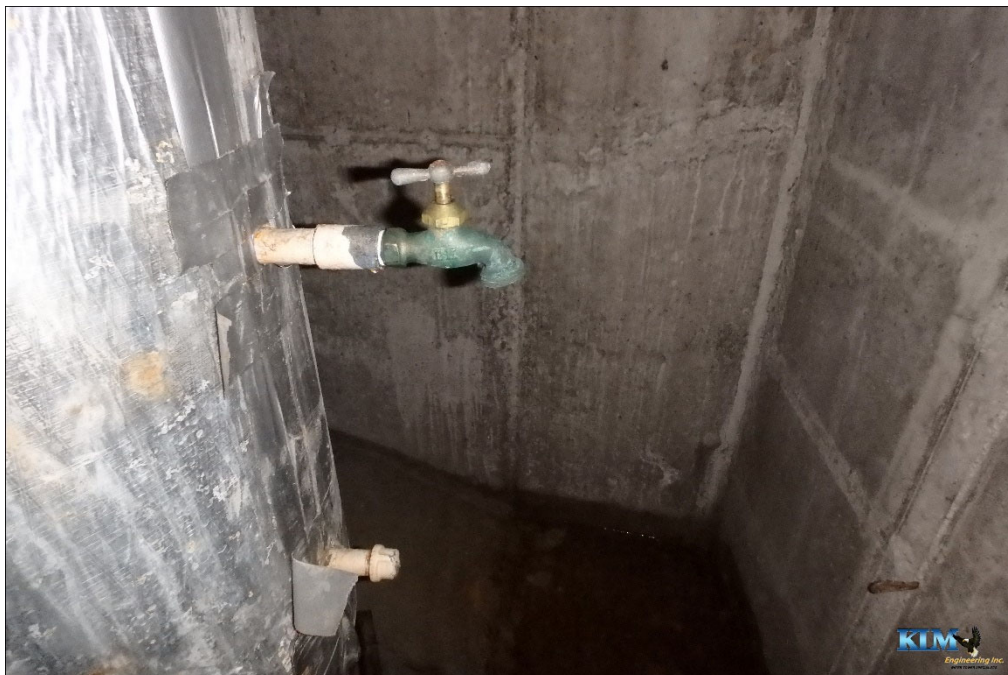
Photo No. 50
Sample tap located in valve pit

- 3.4.13** Replace the non-functioning sample taps in the valve pit and pump house with new taps per WIDNR requirements. See photos 49 and 50.
- 3.4.14** Replace the light fixture in the valve pit with a new LED fixture similar to the Lithonia Lighting OVTWM.

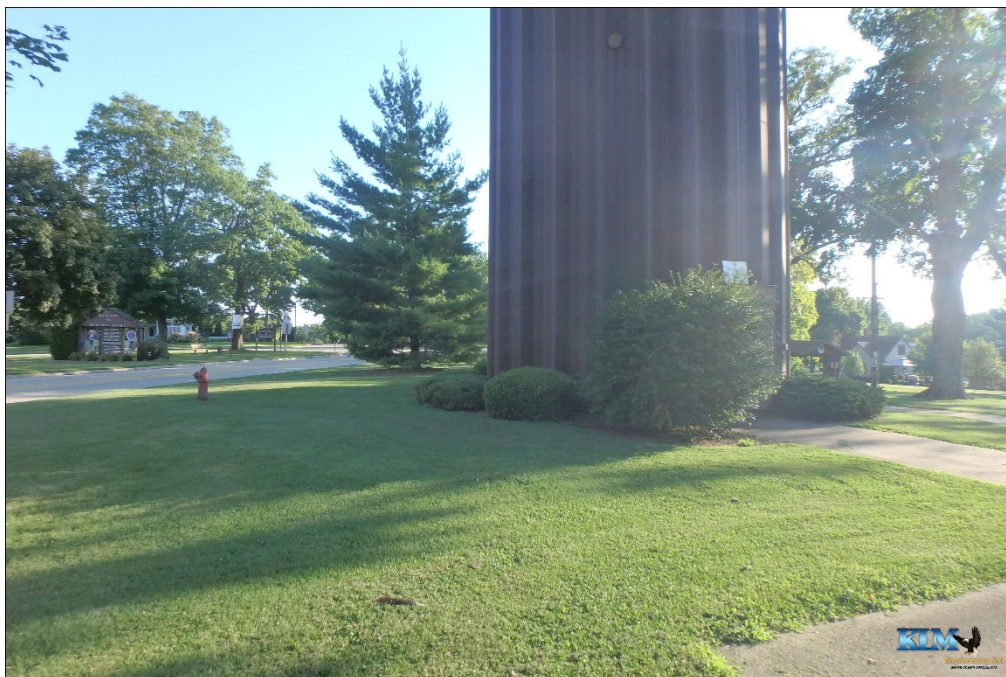
3.8.3 A hydrant is located near the tower that can be used for tower maintenance and appears to have valving that would allow it to be taken out of service. See photo 64.

Photo No. 64
Site conditions near base of tower
Hydrant for maintenance needs visible
